IMPACT OF CORROSION ON MINING EQUIPMENT

J. V. Pellegrino Jr.
Sr. Materials Consultant
RJ Lee Group

34 x 110 mm Chain Splice Link Failures

Analysis of Cracks in AFC Pans - Background

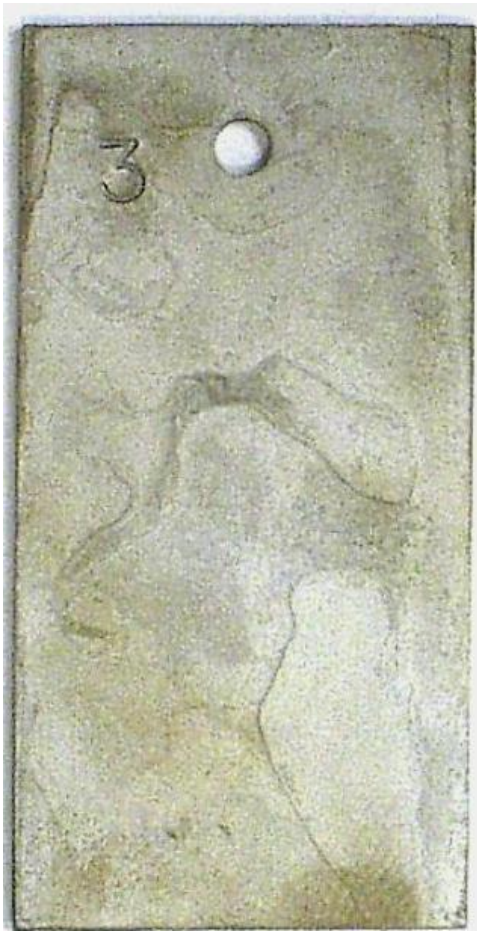
RO Water.

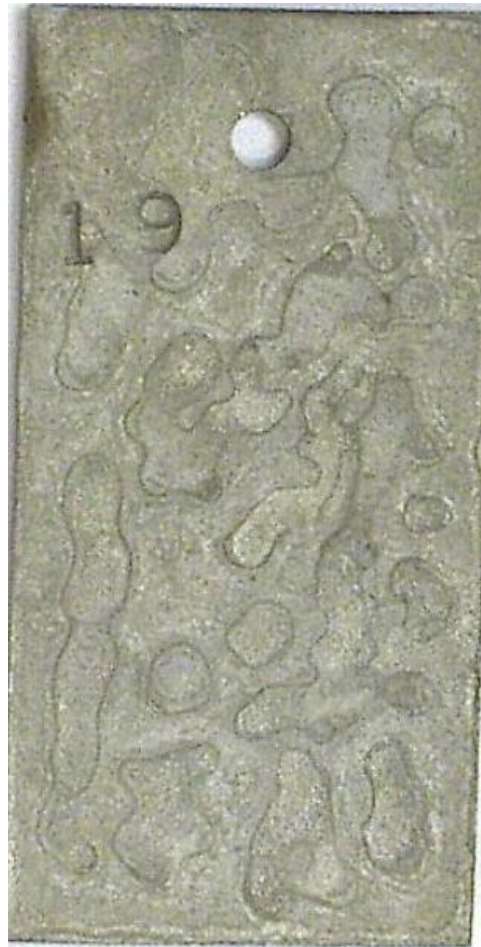
10% RMW.

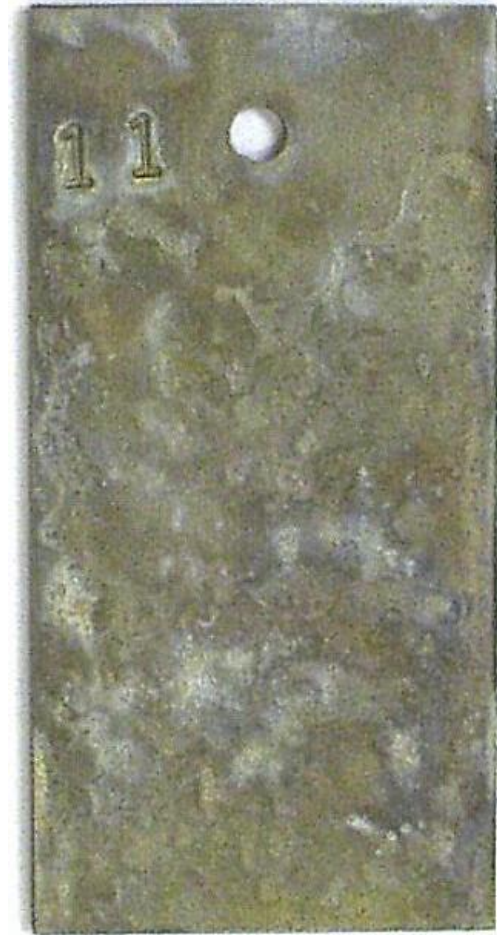
RMW

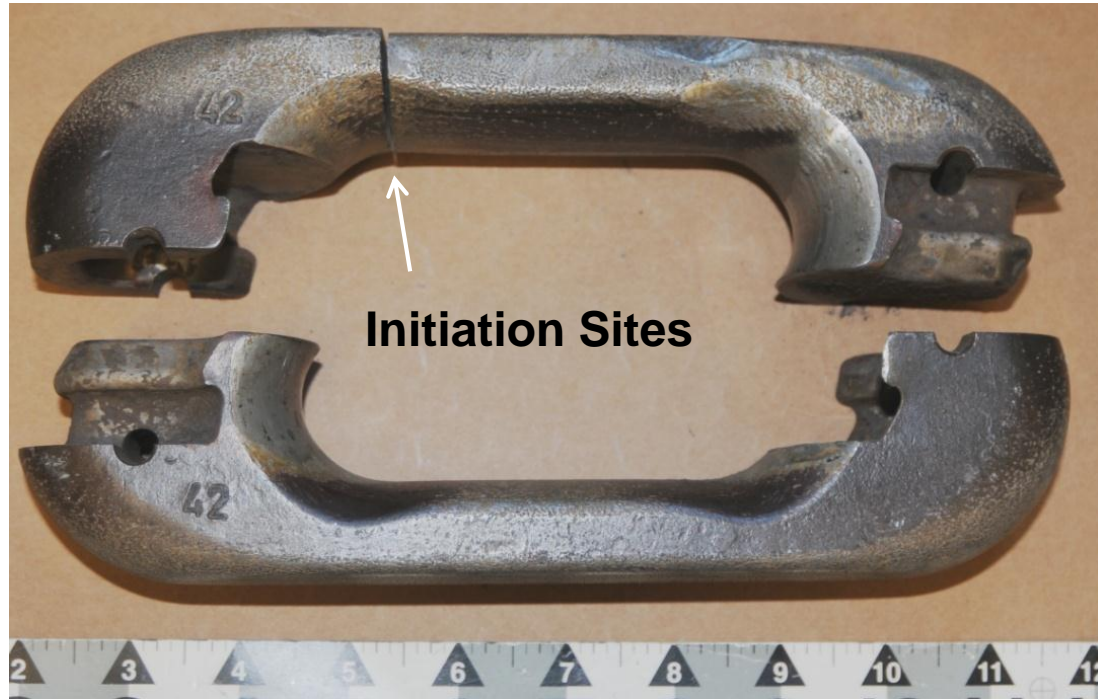
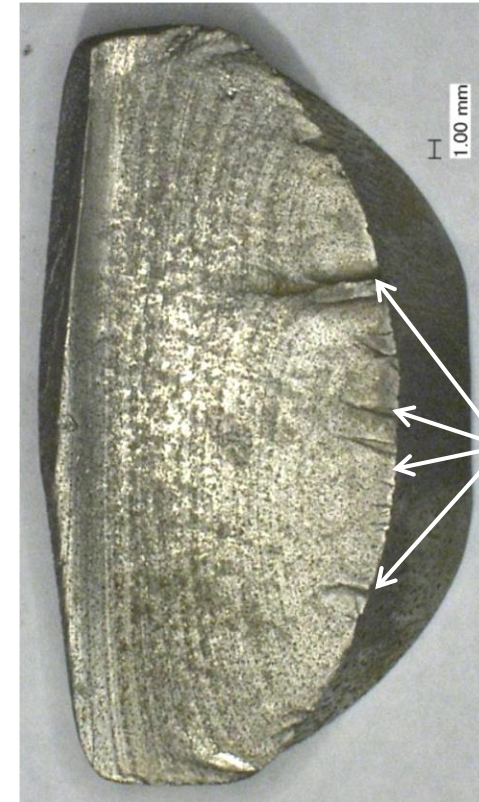
- Link was in service for 3 – 4 weeks.
- Used with non-galvanized standard DIN chain that had a “Tectyl” coating that exhibited satisfactory service performance.
- Alloy steel quenched and tempered to a hardness of 395 HWB (43.5 HRC)/~1337 MPa (194 ksi) and expected to exhibit a breaking load of 2000 kN (450 kips).
- Electroplated with ZnNi.

- Failure was environmentally governed and related to material selection, the environment, and operating conditions.
- Specifically, failure was caused by corrosion fatigue cracks that exhibited multiple initiation sites at corrosion pits on inside surface of links. The cracks propagated completely through the cross section before failure occurred.
- Chemical composition and hardness/strength satisfied the requirements of the governing specifications.
- The ability of the splice link to tolerate a full thickness crack before terminal fracture shows the nominal stresses were low and the material exhibited sufficient toughness for the application.
- Under the same mining conditions, un-galvanized splice links of the same composition and strength level have exhibited satisfactory service performance.

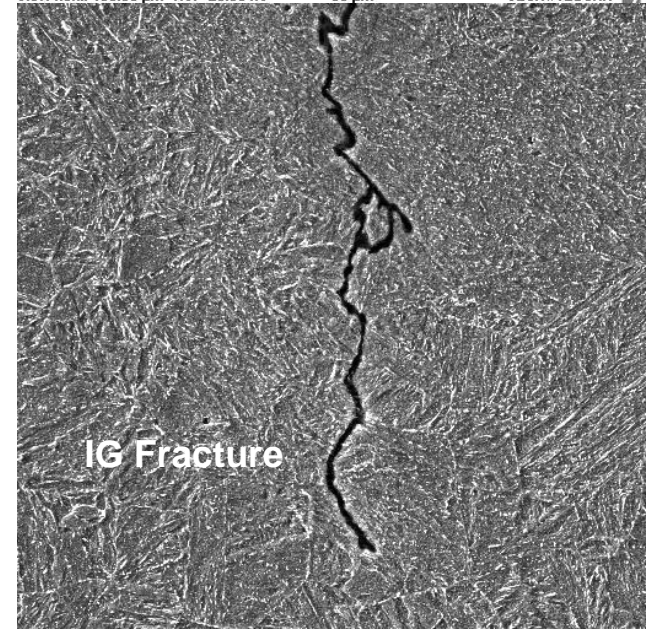
IG Fracture

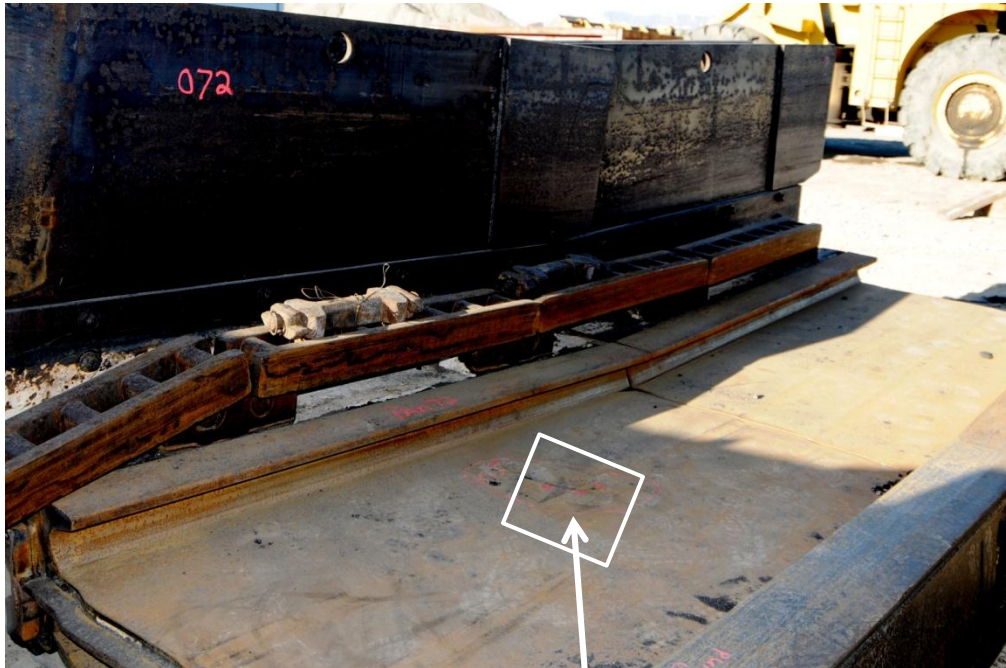
Pan 71 deck plate

- **Visual examination of pans in a rebuild shop revealed the presence of numerous longitudinal cracks in the top deck plate, most of which were within or immediately adjacent to the chain tracks.**

- **Of the 18 pans included in the investigation, most contained multiple longitudinal cracks.**
- **Crack lengths ranged from 50.8 mm to 1778 mm and were present on both head gate (HG) end, tail gate (TG) end or both ends and gob-side, face side or both sides.**

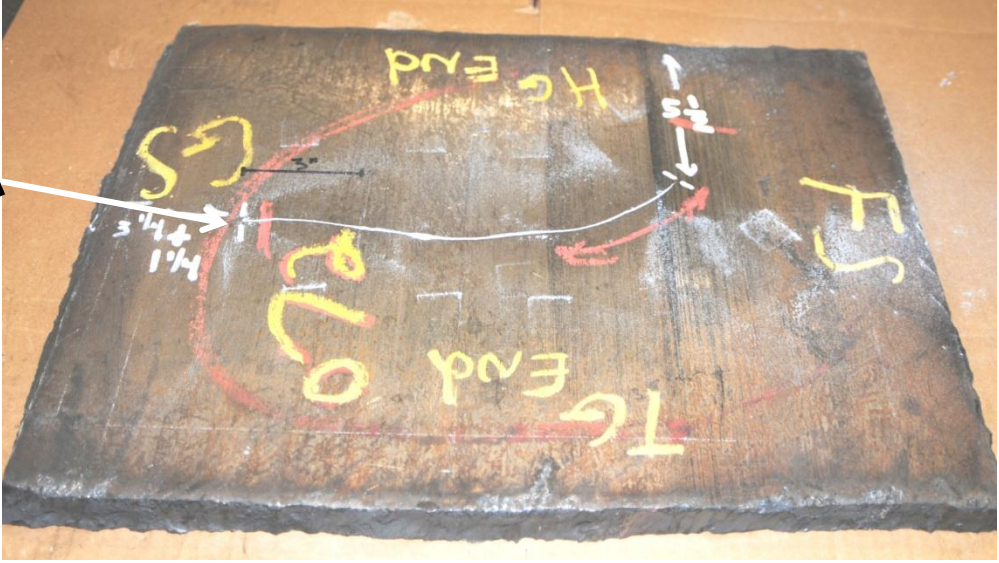
Pan 72 deck plate

Transverse Crack (intersects both chain tracks)

- Other than hardness/strength, the only significant difference between the 450 HB and 500 HB grade material was carbon content.
- Chemical analysis revealed the deck plate containing the transverse crack (Pan 72) was fabricated from RAEX AR 500 (Finland).
- Results of longitudinal (L) and transverse (T) tensile tests revealed there was no significant difference between the 450 and 500 HB deck or the RAEX 500 HB deck plates.
- Results of L and T CVN impact tests revealed that except for the 500 HB deck plate on Pan 133, which exhibited energy values in the range of 14.5 to 17J (10.7 to 13 ft-lbs), the exhibited CVN absorbed energy values were within the range typical for 450 HB (40J (29.5 ft-lb) and 500 HB 30J (22 ft-lb) plate, respectively.

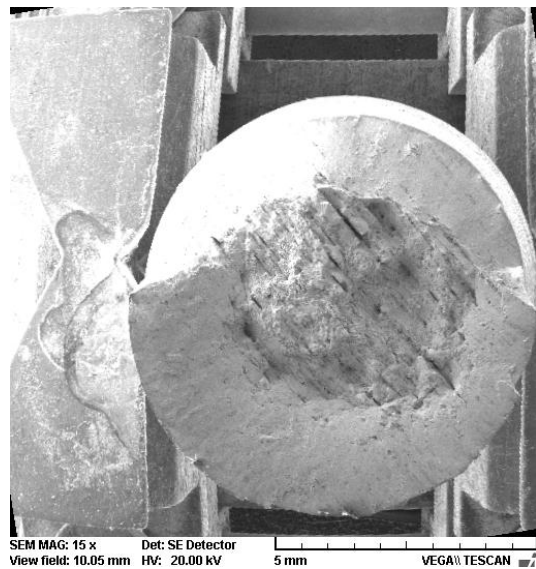
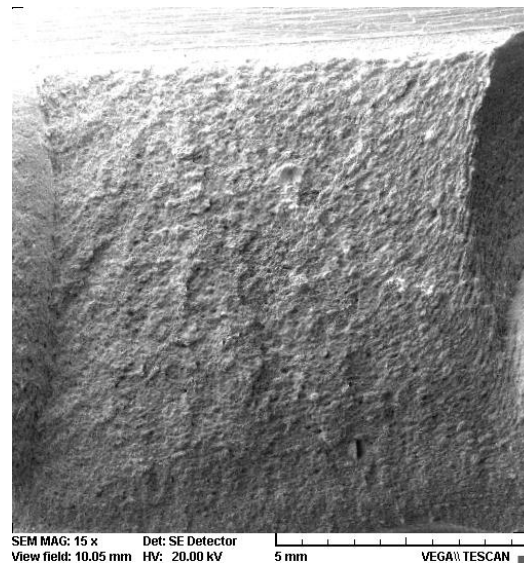
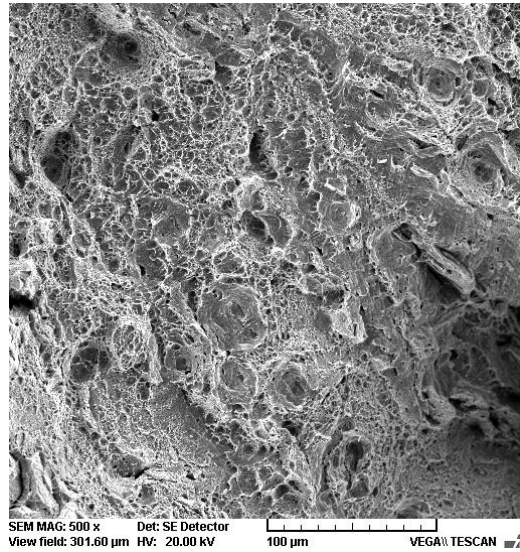
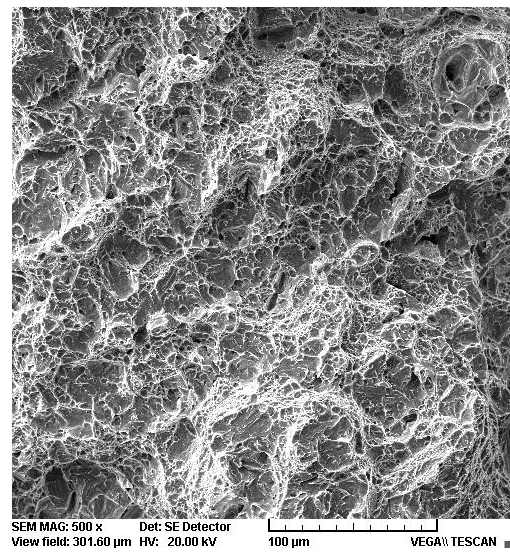
Pan 71 Tensile Fracture

Pan 71 CVN Impact Fracture

Electron images of Pan 71 tensile and CVN fractures showing the presence of predominantly ductile fracture.

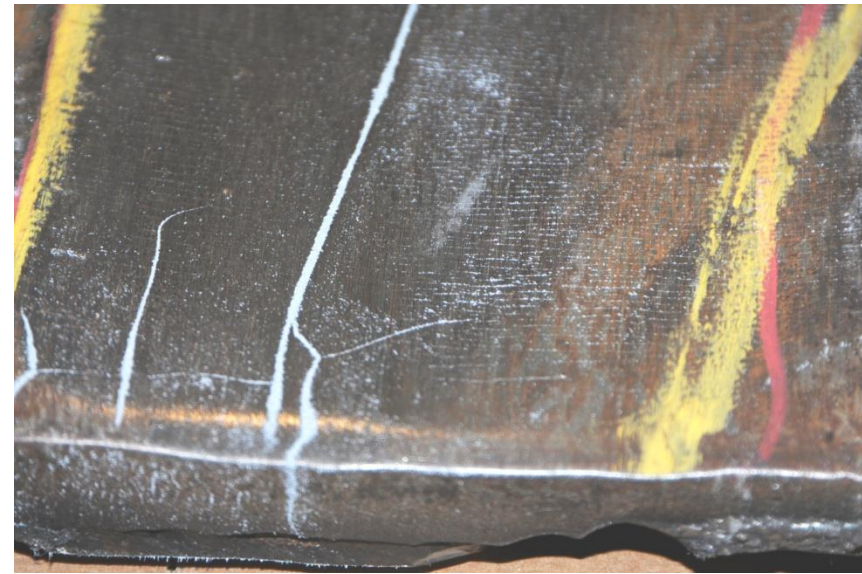
Pan 71 Tail Gate

Crack Arrest Marks

Crack Initiation

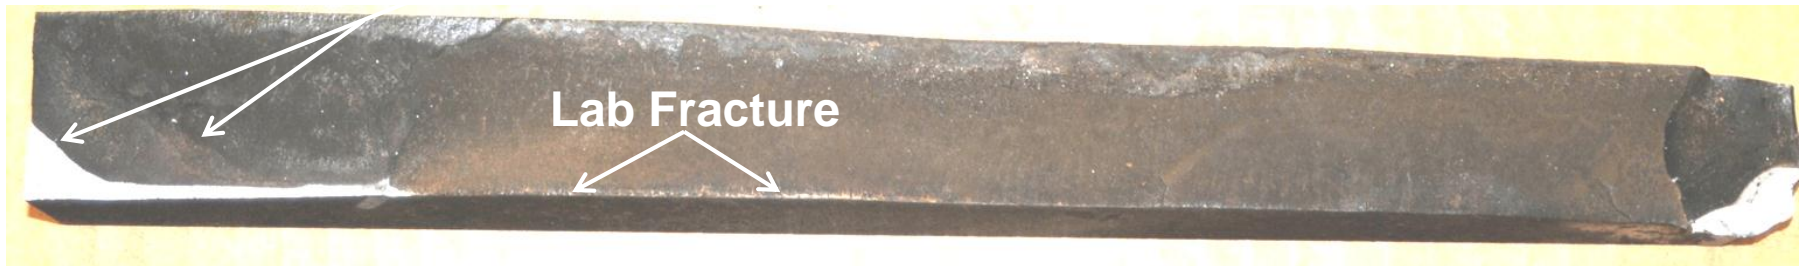
Pan 71 Tail Gate - Opened primary crack.

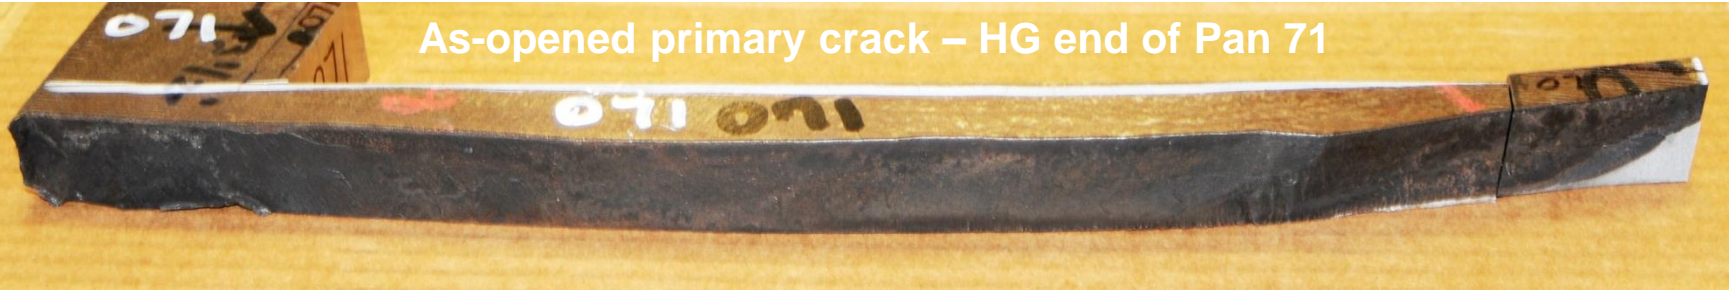
As-opened primary crack – HG end of Pan 71

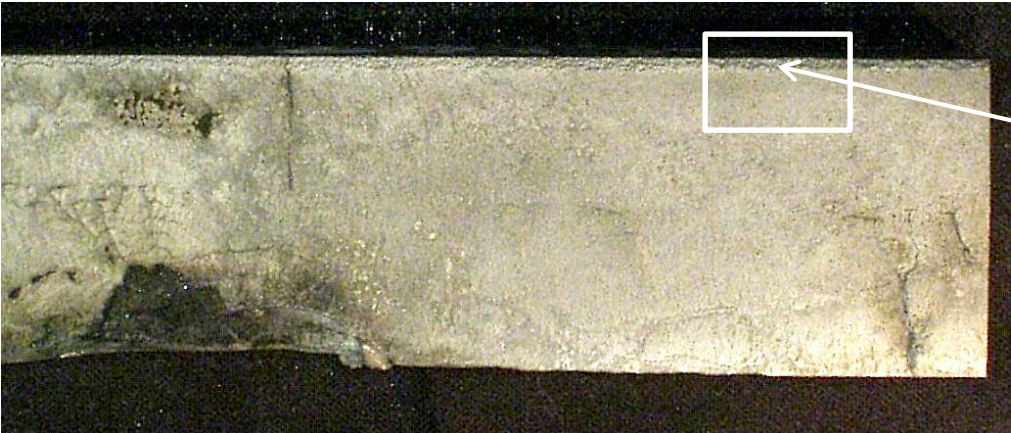
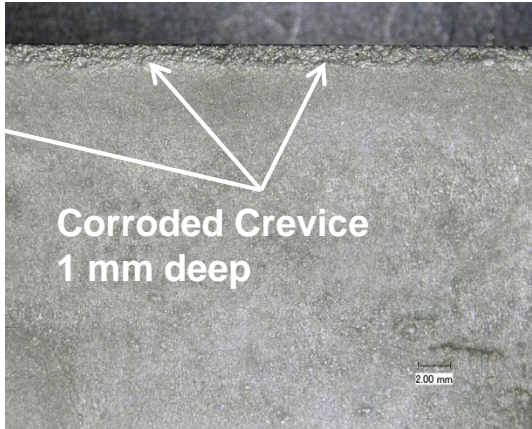
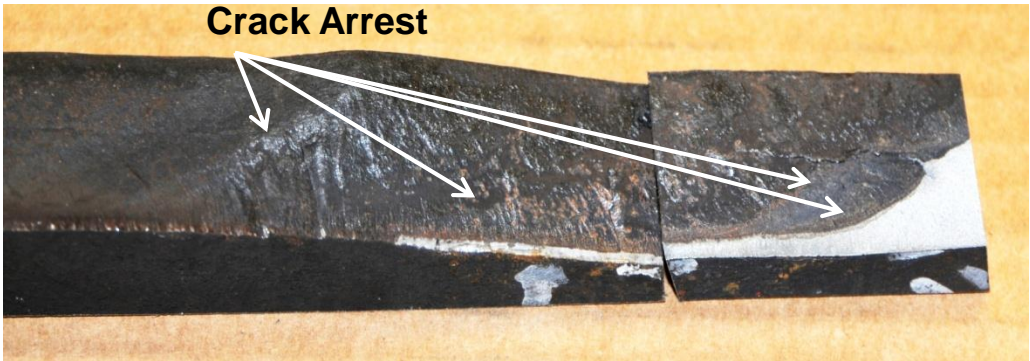
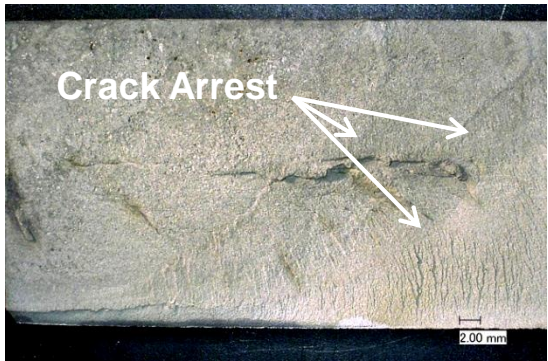
Crack tip of major crack in Head Gate end of Pan 71.

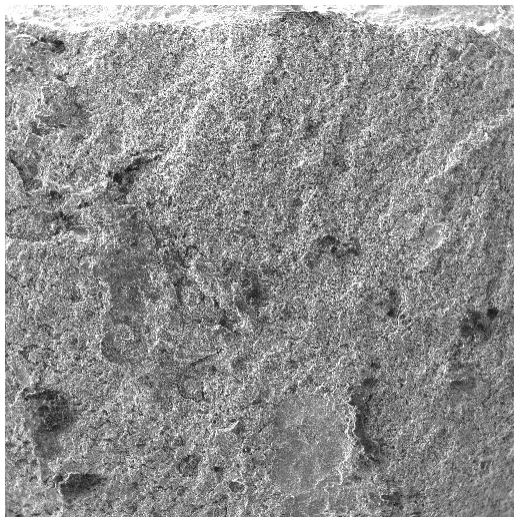
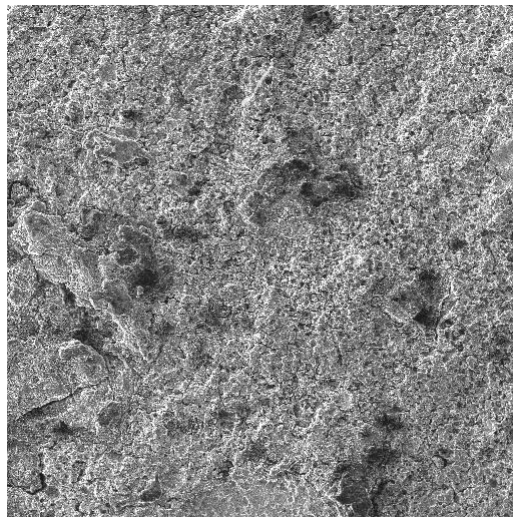
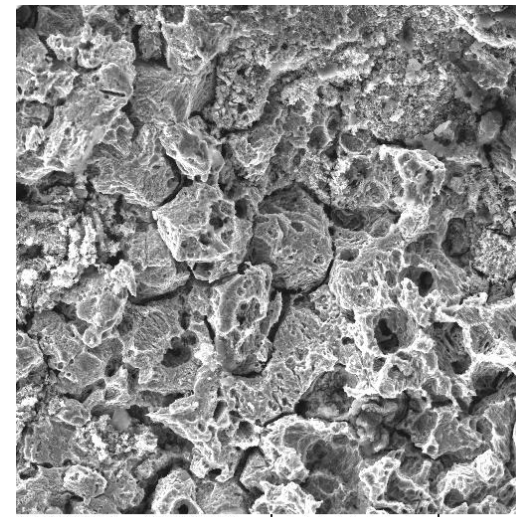
Intergranular fracture near chain contact surface at HG end of Pan 71 deck plate.

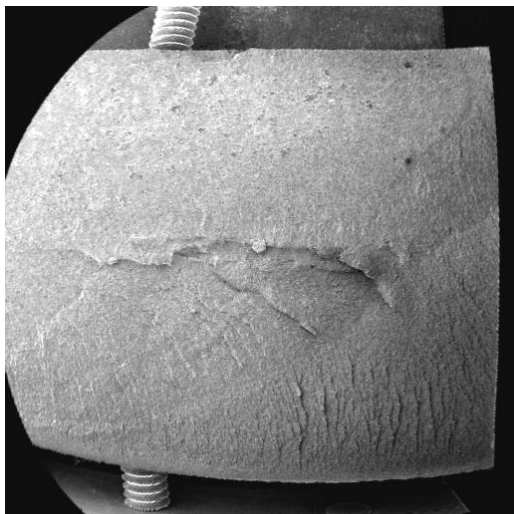
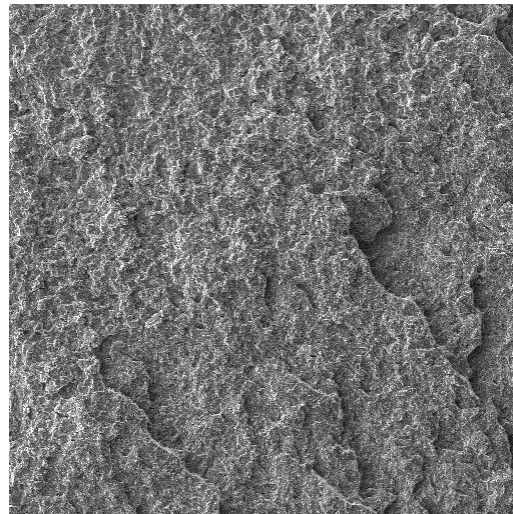
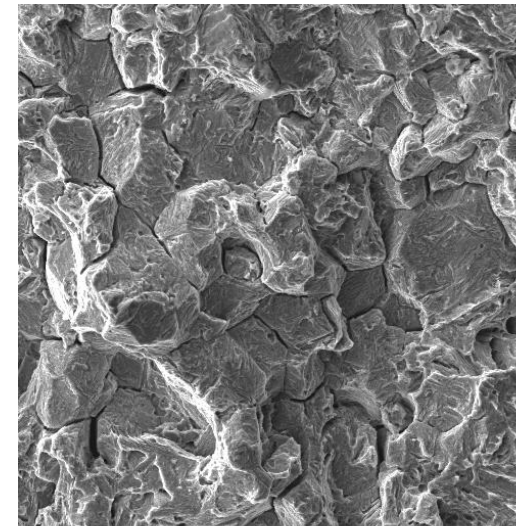
Intergranular fracture at crack tip at HG end of Pan 71 deck plate.

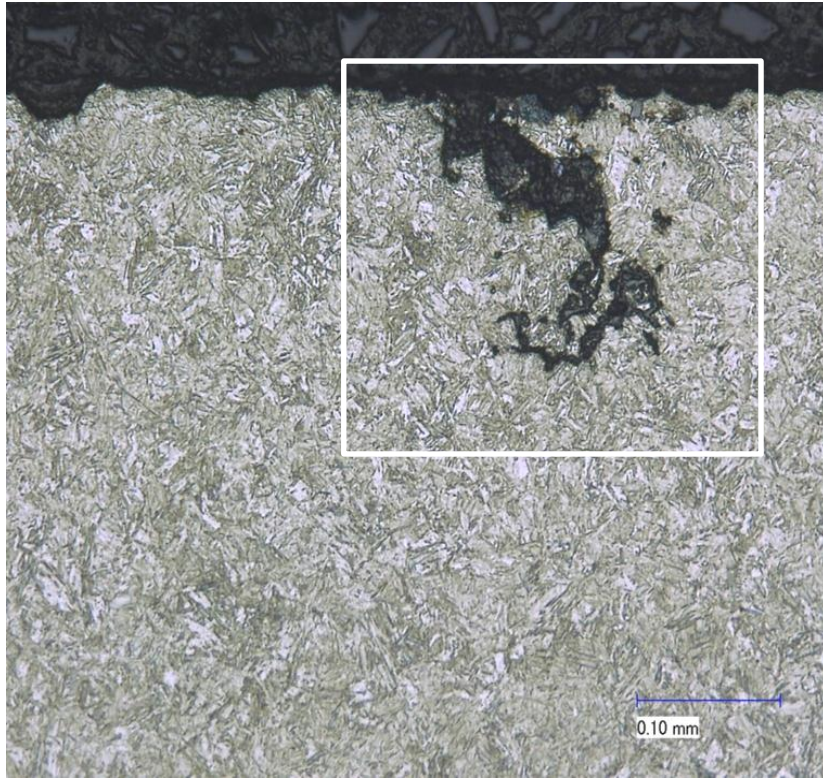
0.16 mm deep IG crack on chain contact surface of Pan 71 deck plate.
