A Case Study of a Low Overburden Longwall Recovery With Pre-Developed Recovery Entries

Signal Peak Energy, LLC.

Abstract

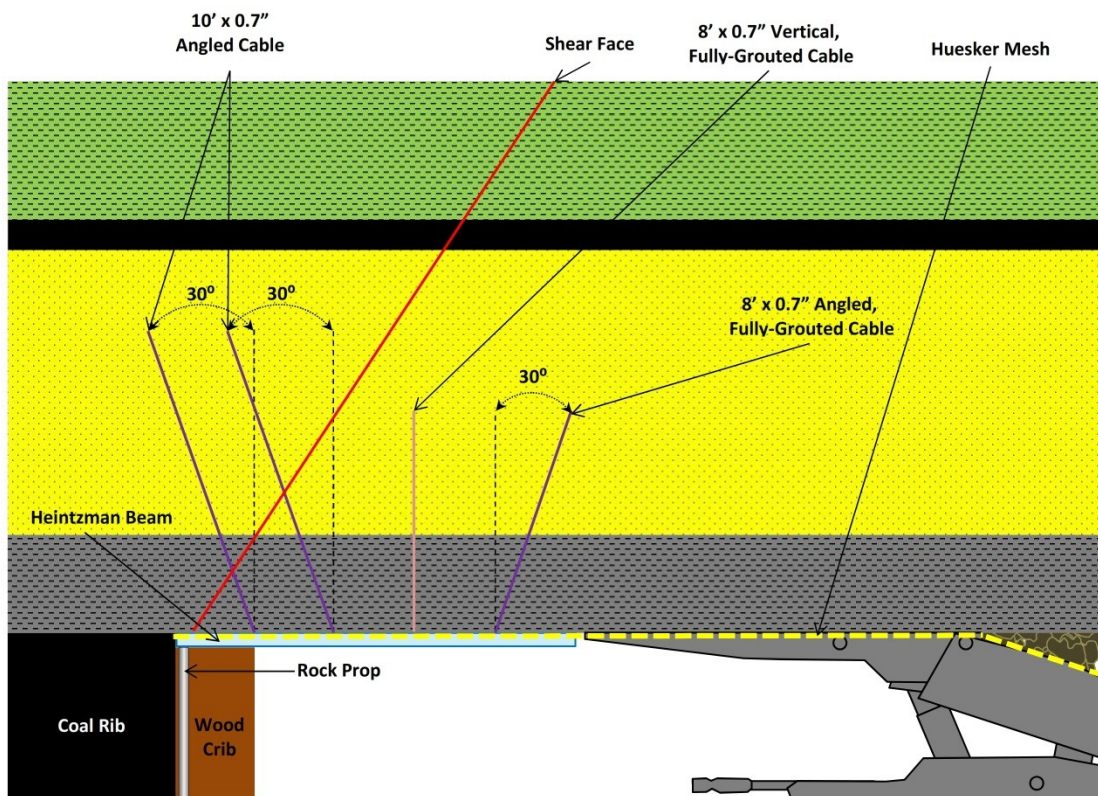
Post Event Roof/Supplemental Support
Installed with "Fletcher Bolter" after AFC removed

- During extraction of the AFC, headgate and tailgate we started to develop a cutter on the solid rib line.
- It was decided at this time to bring in the Fletcher roof bolter and spend the time to bolt the face with a denser and more substantial support .

- The cutter continued to worsen and the roof was displaced.
- A continuous miner was brought in to grade head to tail to gain height and expedite the shield extraction. This made it easier to shoot the floor out from under the iron bound shields.

- We started building 2ft X 4ft cribs along the solid face. Heintzman beams were placed on top of the cribs and staggered and placed over the shield tips.

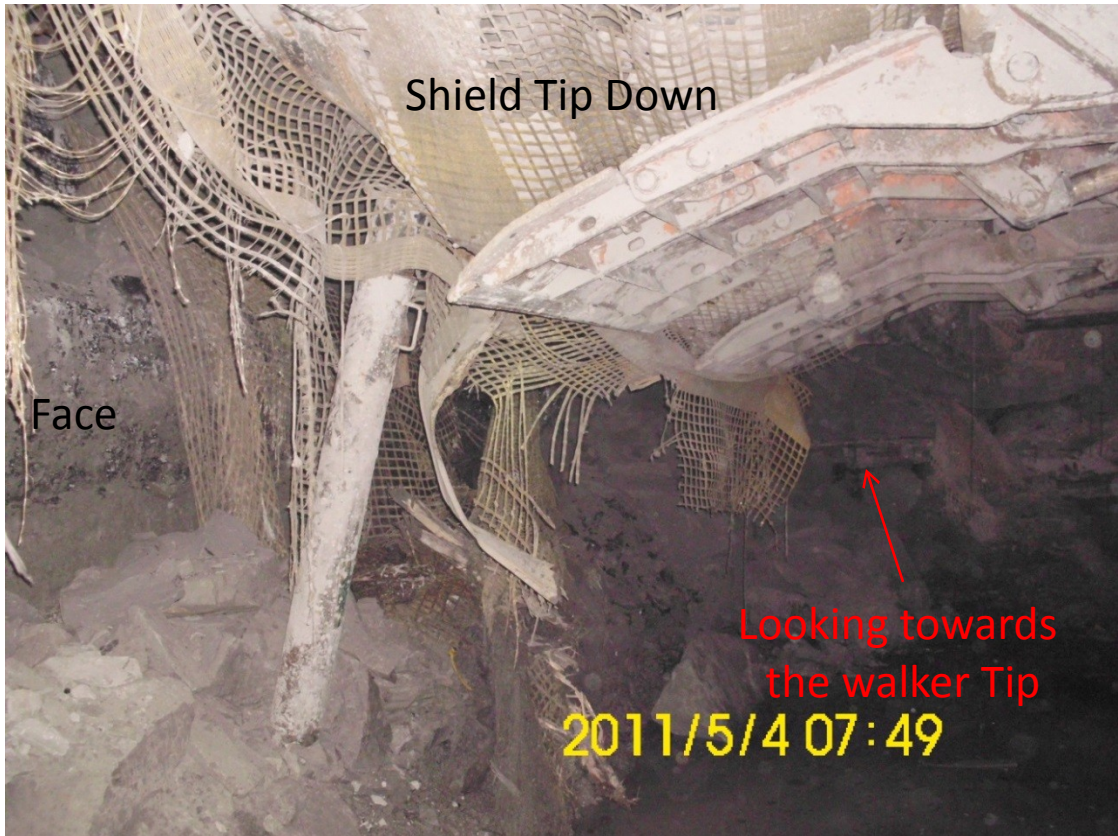
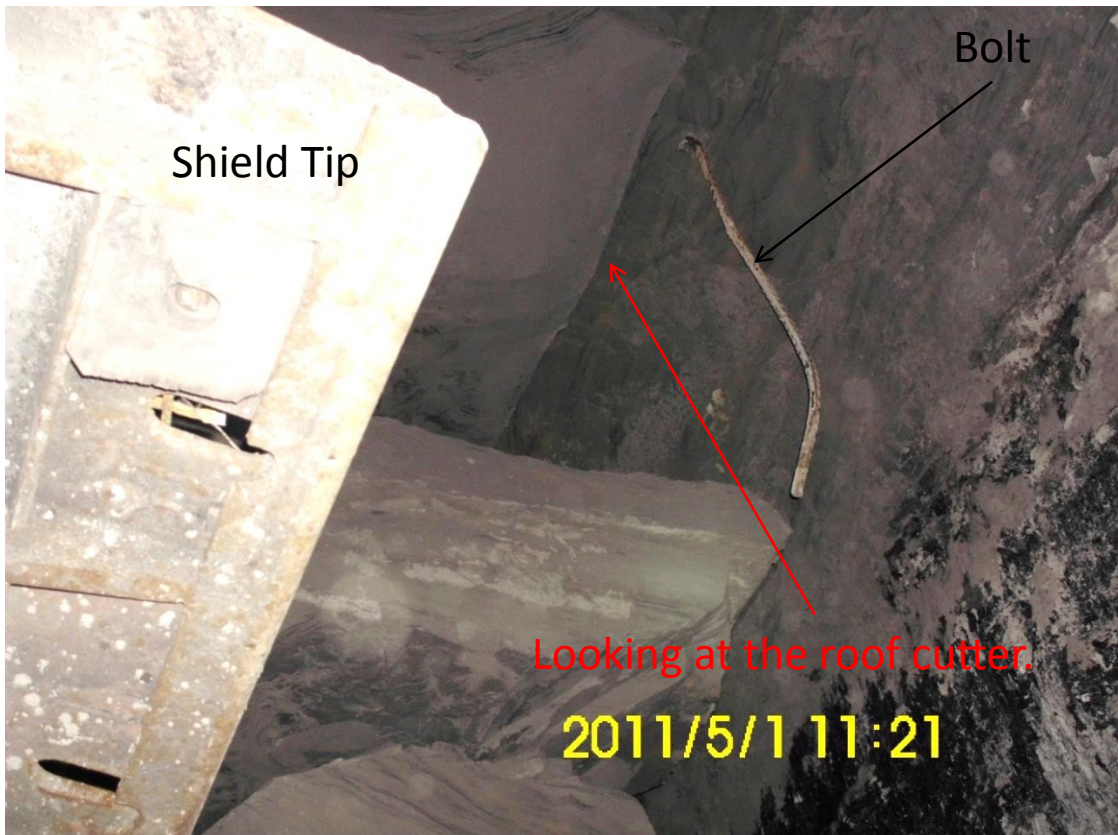
1R Conventional Move After Shield 40 Event

- Then weighting event occurred, and shields 40 to 130 were collared, it was a fight with each and every one.
- The longwall extraction took 55 days (hanging mesh to final shield pulled).

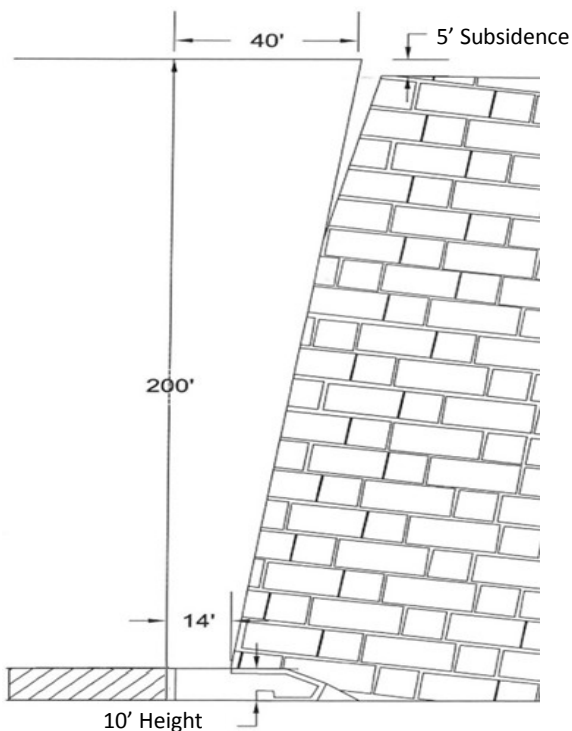
- Analysis of the 1 Right Recovery Room showed a significant angle shear with subsidence expressions from the recovery room to the surface.
- Its determined that the roof failure included both the immediate roof and the overburden rocks.

1 Right Conventional Cave Observation
No Forward Abutment

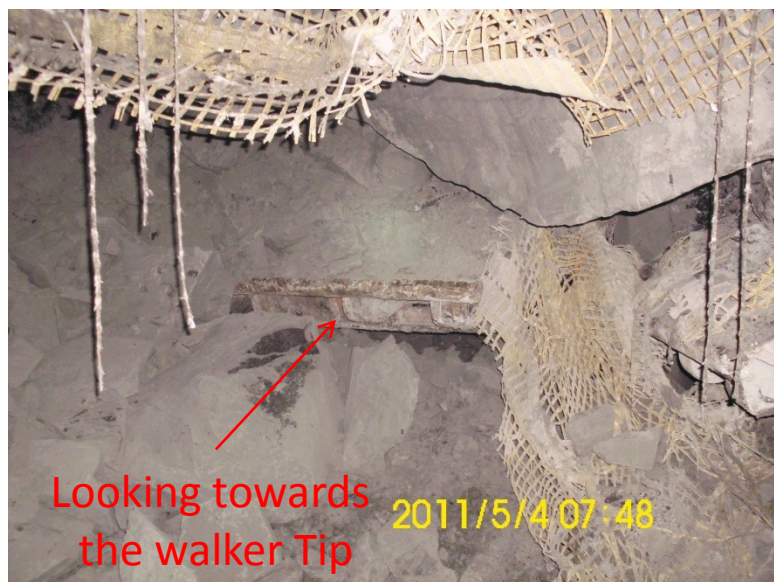
1 Right Conventional Buried Walker

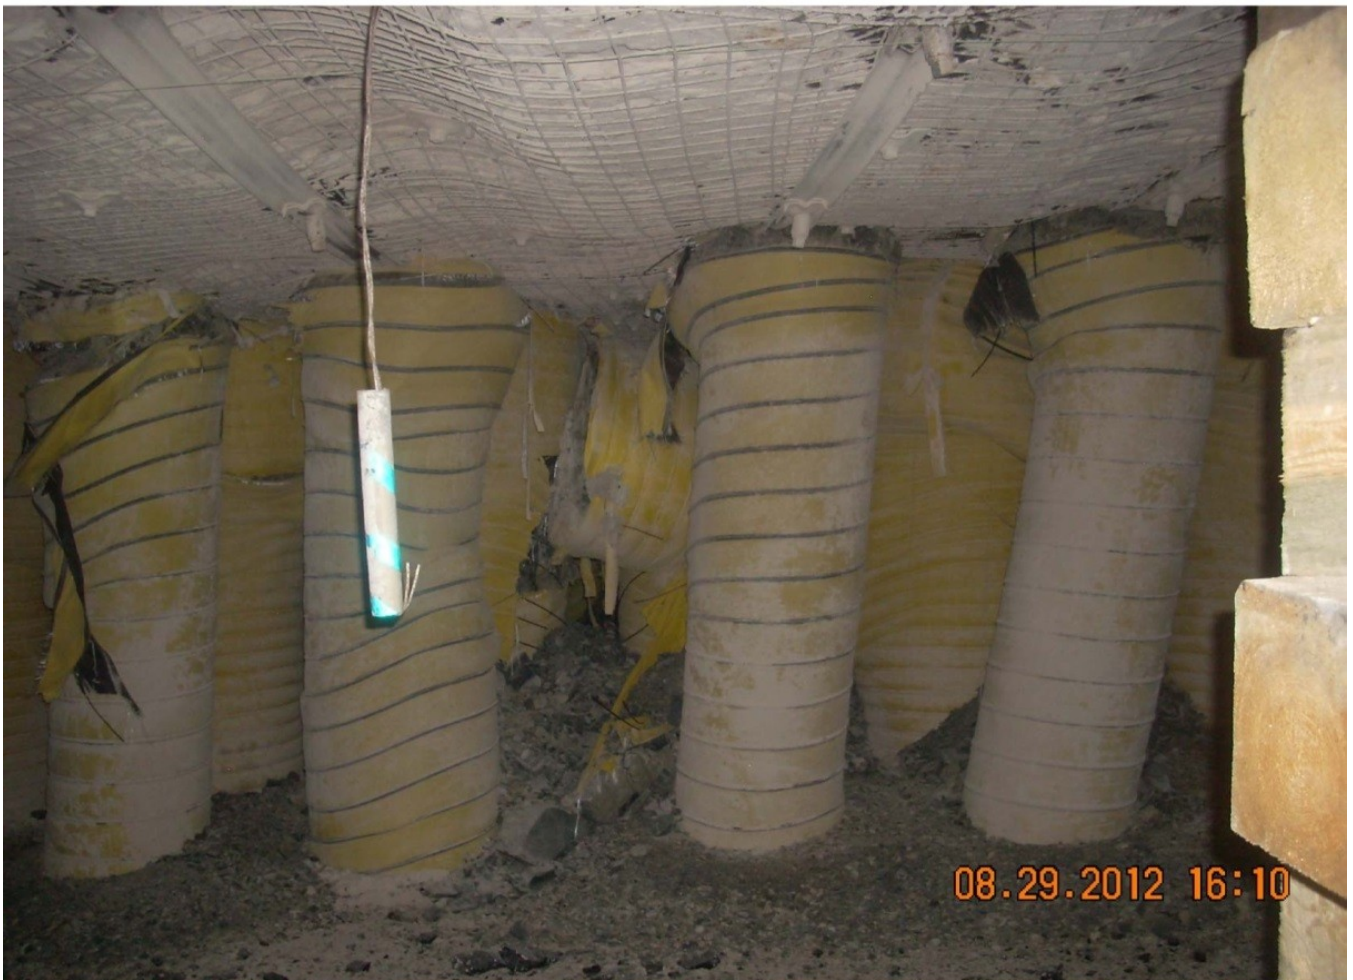
- When the fender pillar was approximately 15 feet at the tailgate and 18 feet at the headgate a weight transfer occurred. Both the shields and the standing support were immediately converged approximately 24 inches. After the weight transfer event many of the shields were ironbound.

- Shield toes were blasted and recovery work continued. The sudden convergence damaged the yield valves. The yield valves were replaced with rock burst valves .

- Damage was found at the chutes at the rib line in two of the chutes, #4 being the worst. Several of the pumpable crib in the recovery room had failed.

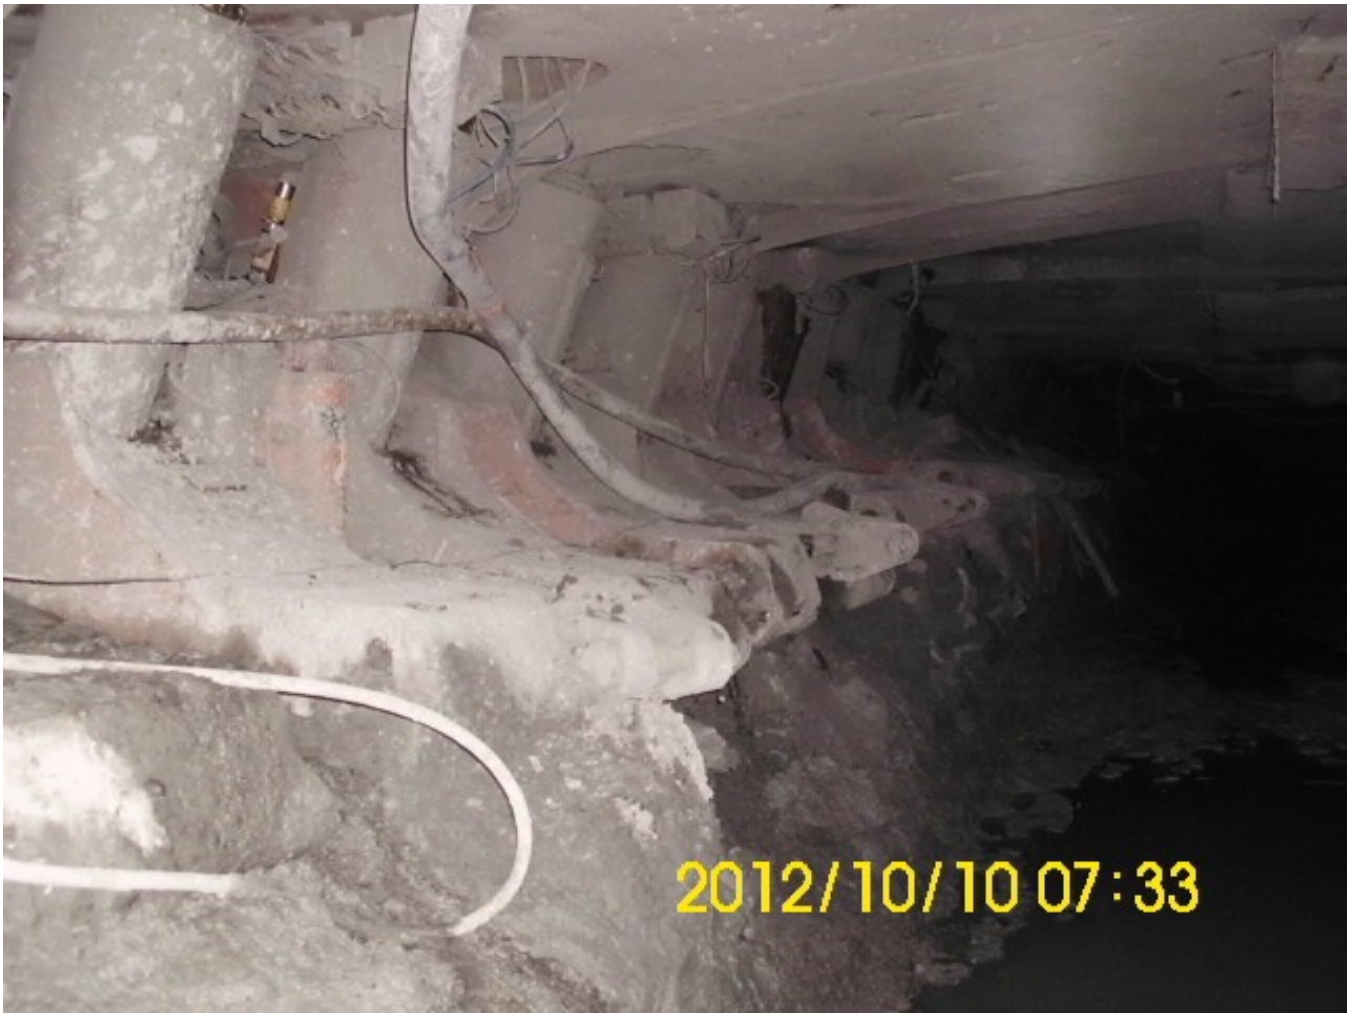
- Shield legs were iron bound and shield tips were down bad enough to prevent mining with the shearer.
- We installed standing support (water props and prop-setters in the recovery room in all intersections of the chutes in line with the solid rib line.
- Then we continued to set the same support along the solid face / rib where the pumpable cribs had and were failing.
- Once again we were developing a major cutter along the face / rib line.
- On the face side we decided to park the shields where they set and started to extract the AFC, headgate drive and tailgate drive.
- We then brought the continuous miner in and graded head to tail for extraction of the iron bound shields.
- Back to the recovery room solid pillar side we strung out brattice for a form along the new standing support that had been installed. (8 foot average thickness)

- Tech-seal was pumped into this void to create a pack wall matching a 900 psi coal strength. With the pack wall completed and a minimal cure time all convergence slowed.
- Shields were extracted at a slow pace due to the majority being iron bound and the Huesker mesh not being in the desired or proper position.
- The longwall extraction took 60 days (hanging mesh to final shield pulled).

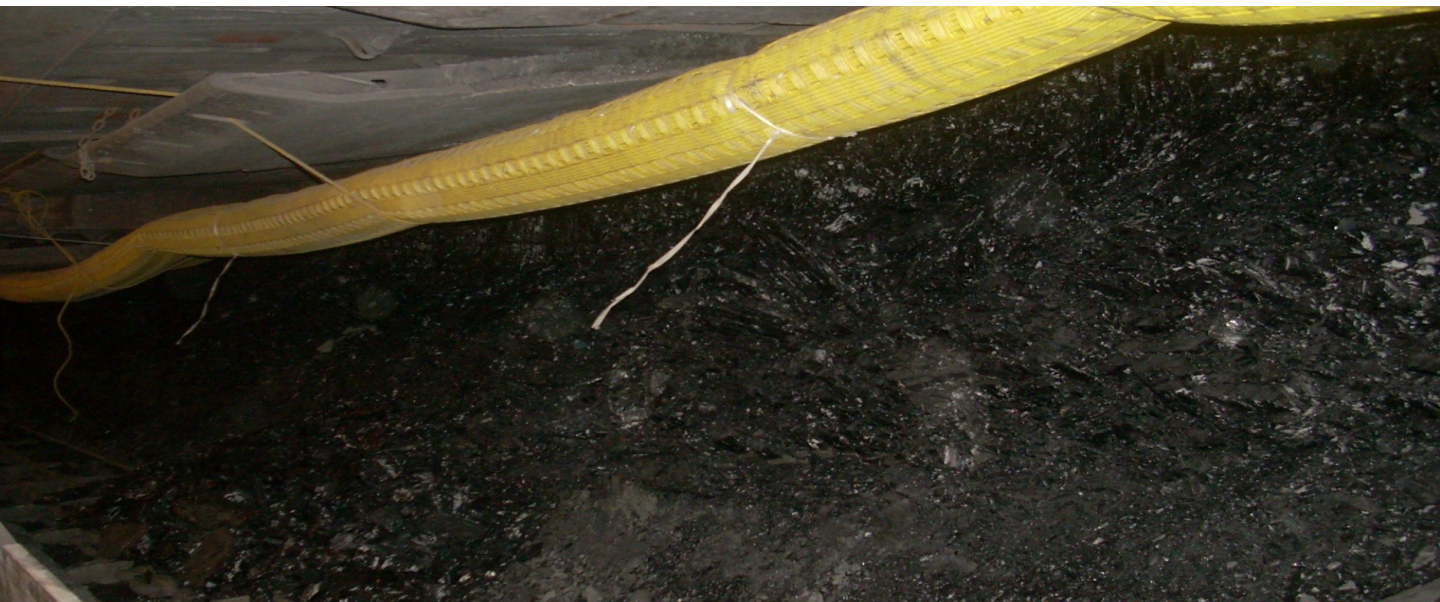
- Prior to the weighting transfer the normal mining rate was reduced due to the meshing installation.
- When the fender pillar yielded the shields converged, and the standing support failed.
- The standing support density of 0.34 was underestimated.

Fender Failure

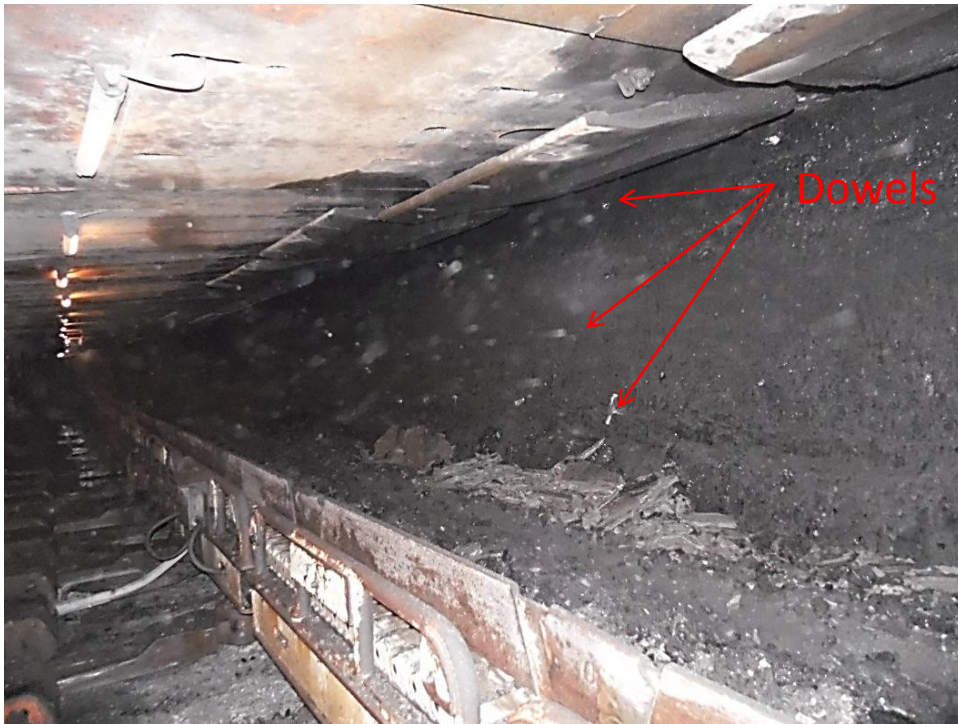
Mining the coal fender, no roof spalling. The face is standing straight. Mining within 13 feet of the backfill.

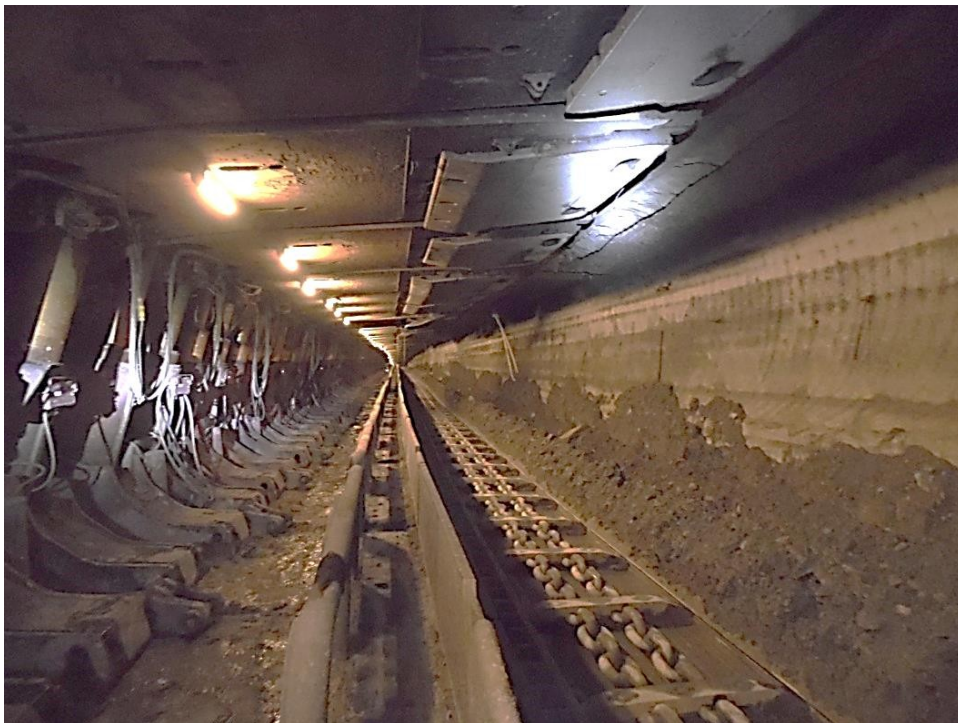
Mining the concrete backfill, no roof spalling. The face is standing straight.

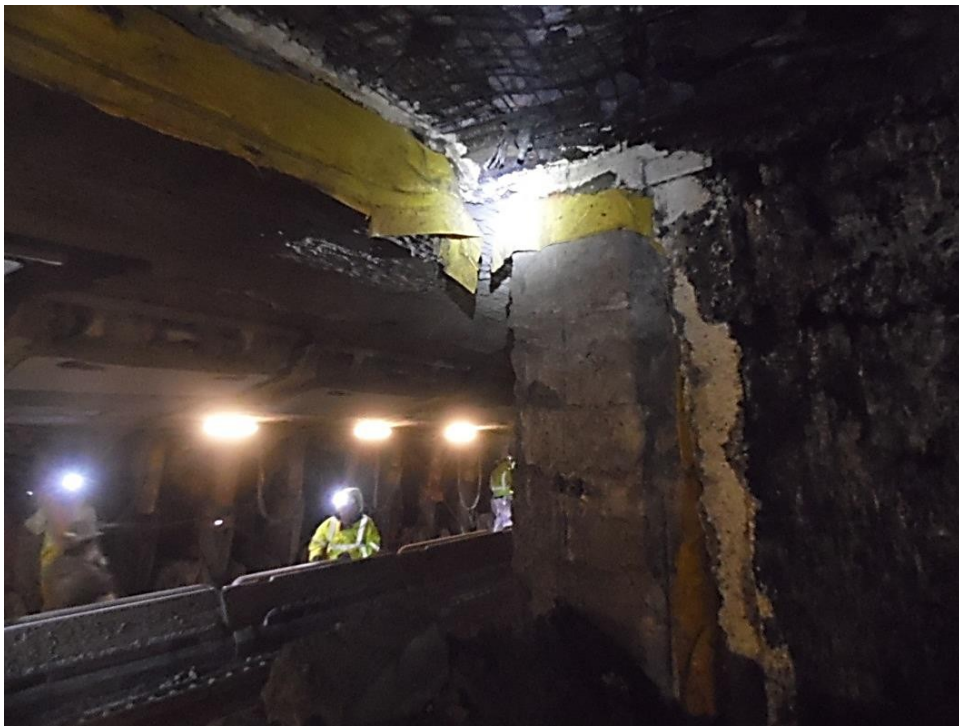
Breakthrough to chute 2, no roof spalling. The face is standing straight.

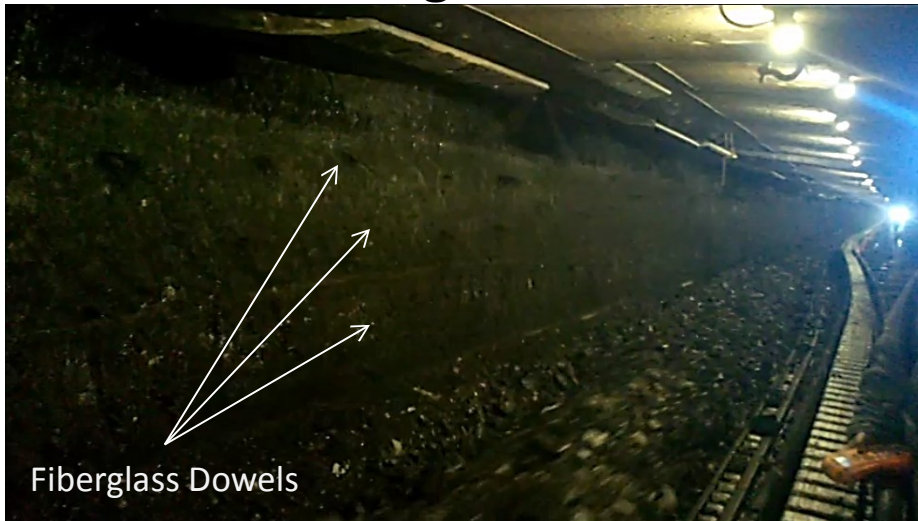
Mining the coal fender approx. 5 feet of backfill. The fender is standing straight.

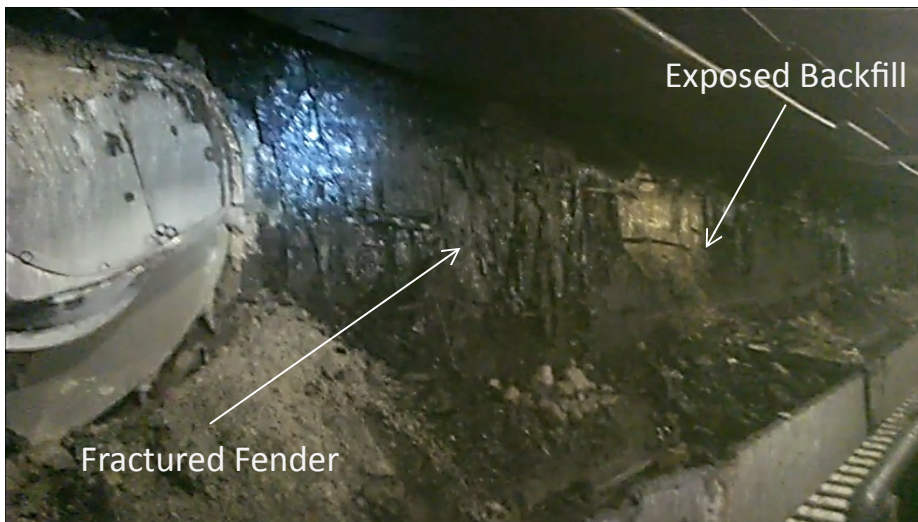
Mining the coal fender, first cut into backfill. Shield leg pressures showed loading.

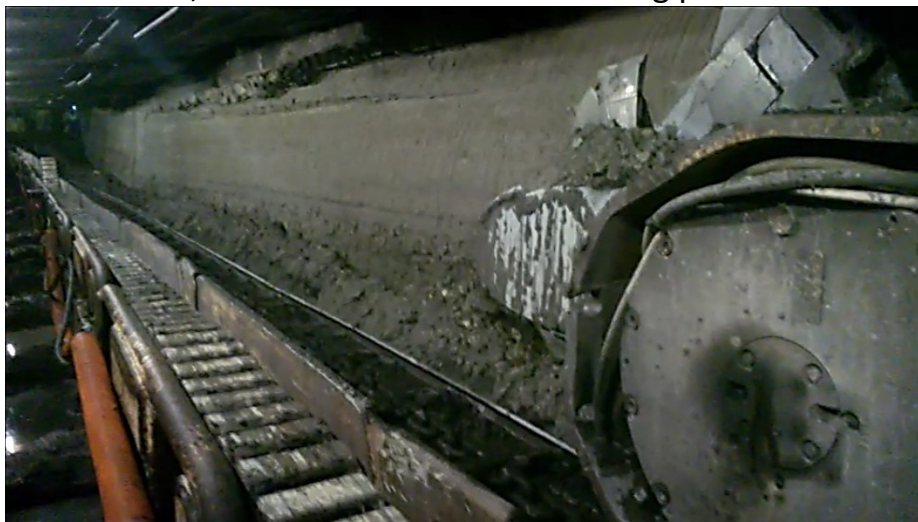
Mining the concrete backfill, no roof spalling. The face is standing straight.

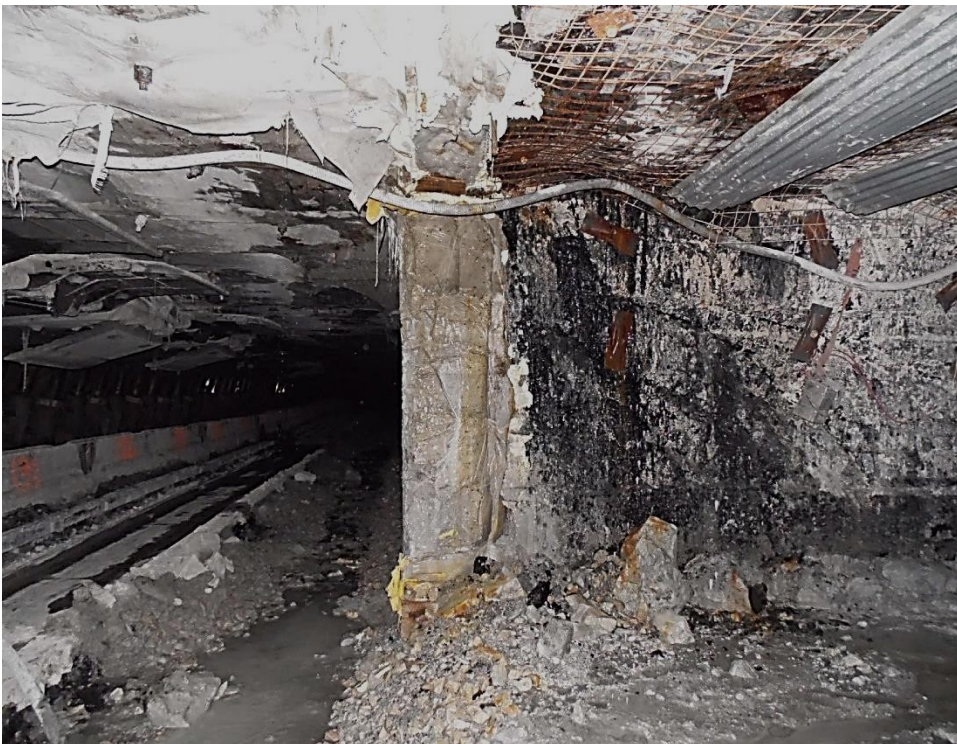
Breakthrough to chute 4, some spalling. The face is standing straight.

- TG inby the face remained stable.
- Cracks and pillar corner sloughage observed in chutes 1, 2 and 3.
 - Loading occurred after the shields had set for five days. Inconsistency with a portion of the backfill.
