# Extending the life of LW Roof Supports through the use of a Life Cycle Testing Management Plan

Allan Black  
Product Manager  
Komatsu Mining Corp.

## New Denmark – Case Study

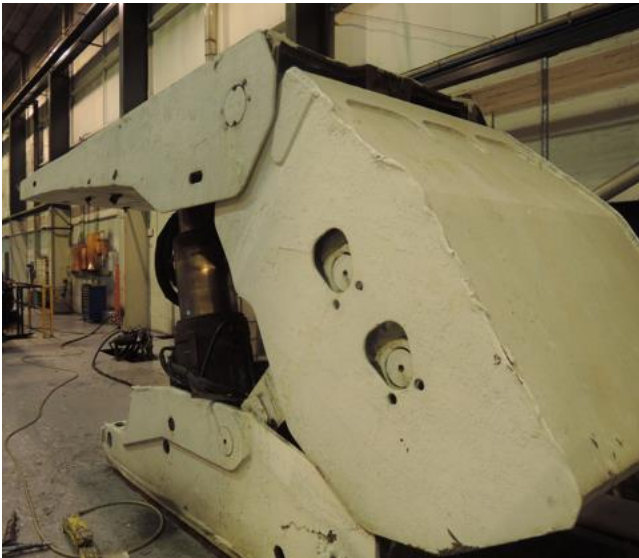
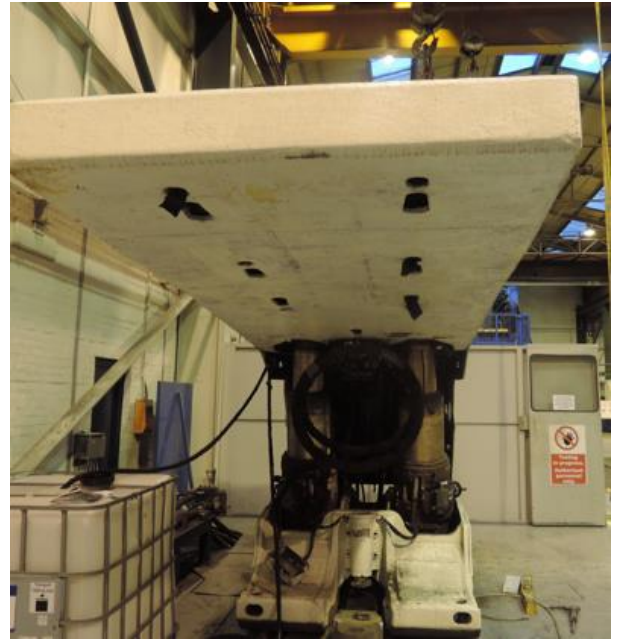
The support had seen 13,000 underground cycles

And seen some pretty tough conditions

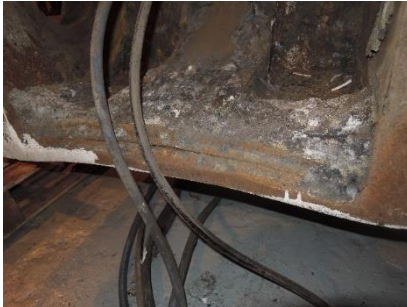
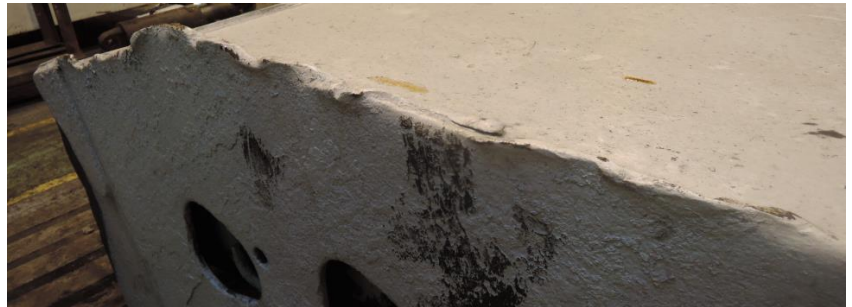
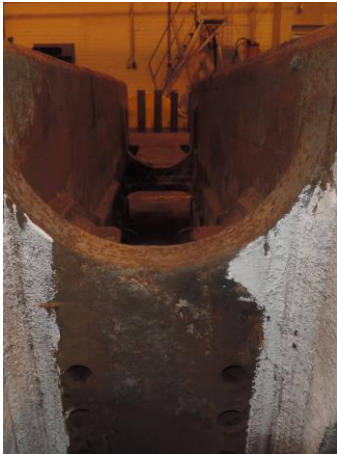
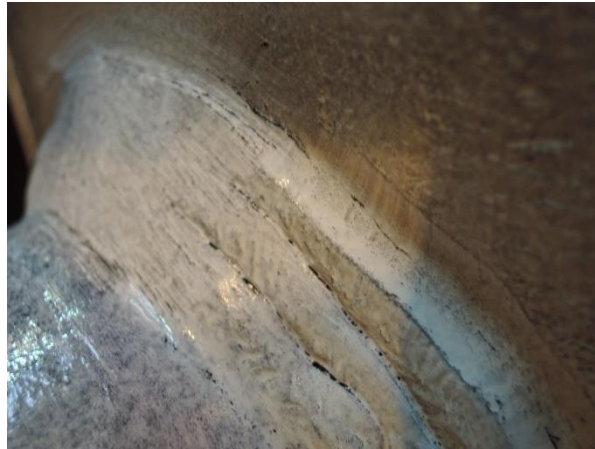
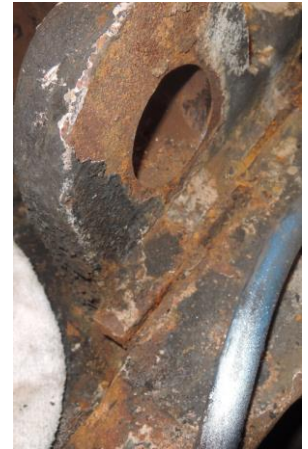
All cracks & damage identified and assigned unique crack ID marks

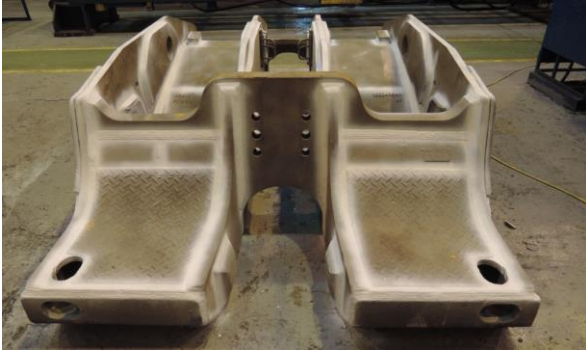
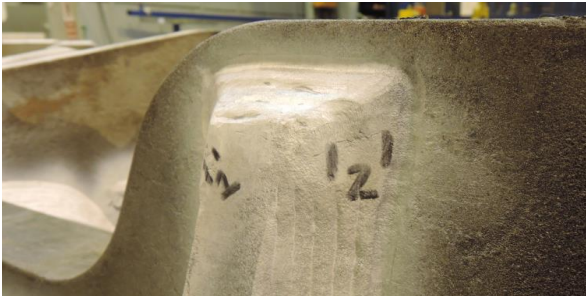
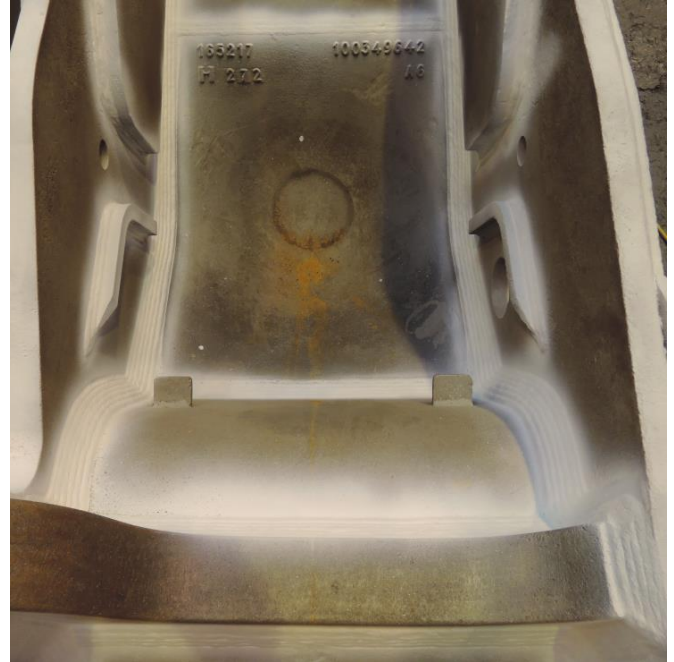
The components are then shot blasted and visually inspected with the addition of magnetic particle NDT testing to establish the location of any additional weld cracks

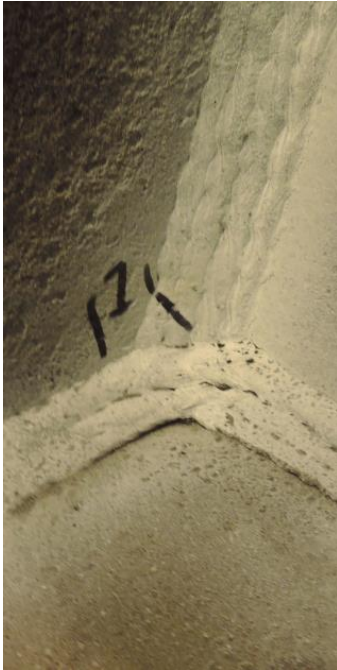
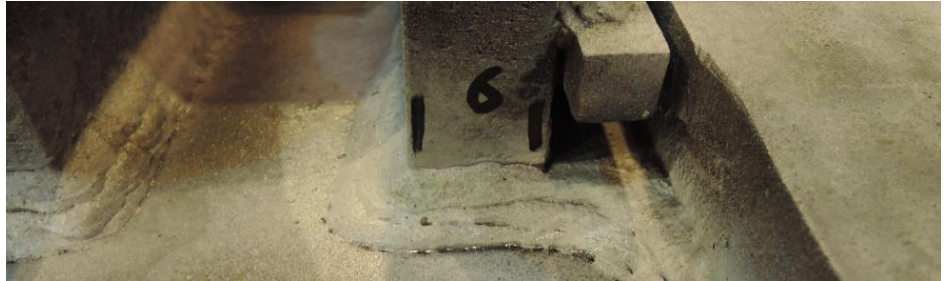
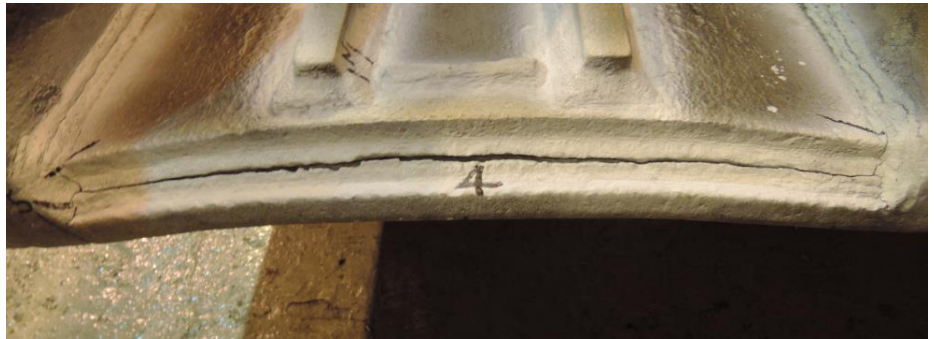
The components are then shot blasted and visually inspected with the addition of magnetic particle NDT testing to establish the location of any additional weld cracks

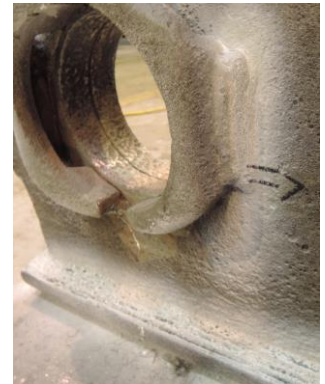
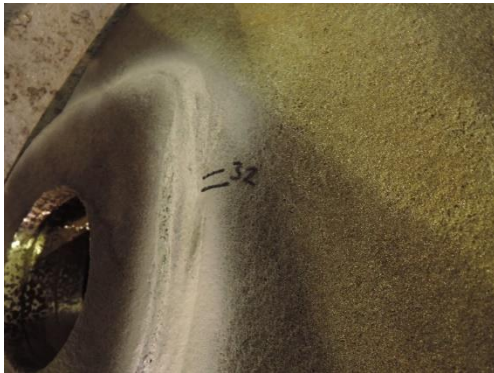
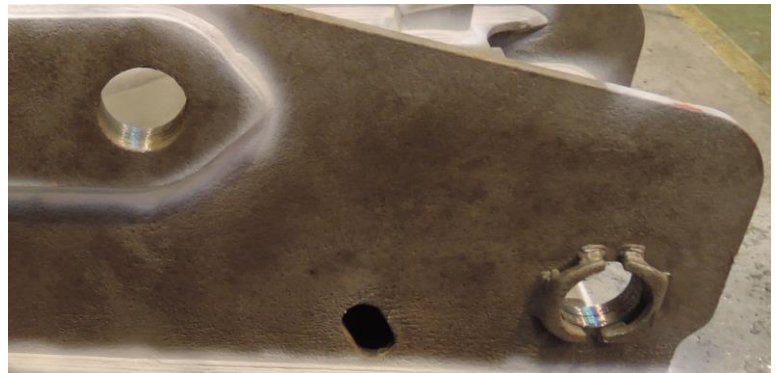
Hinge pins and bores were also examined, measured and recorded.

Bore Diameter  
nominal 142

Pin Diameter  
nominal 138

Wear of 3mm

Upper link base doublers (fig 5.7)	30,000	Area to be monitored
Bores		30,000	To be repaired when Joint clearances exceed maximum OEM recommendation of 2mm
Lower Link (LH and RH)	N/A	25,000	Replace link

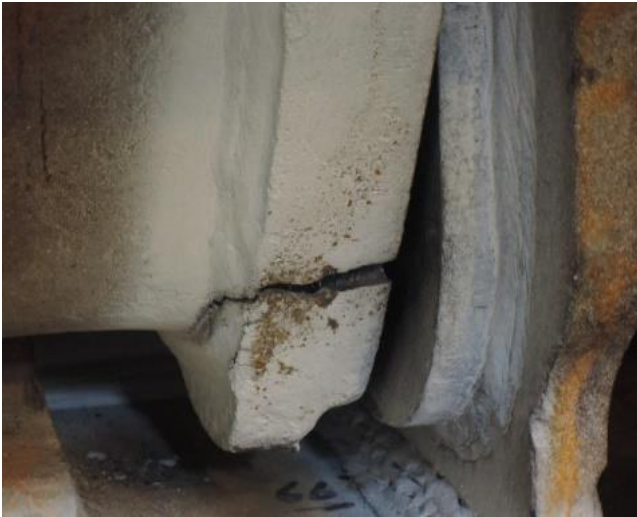
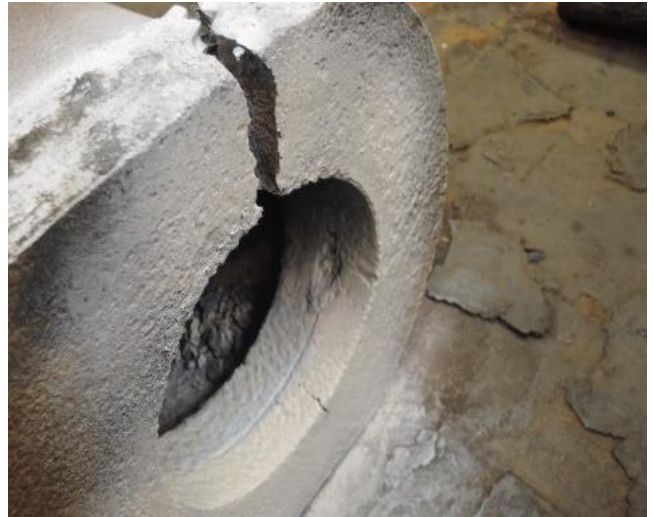
During phase 4, at 19,000 cycles (a total of 32,000 cycles including these seen underground) there was a catastrophic failure of the lower links, and the test had to be suspended.

The lower links were replaced, and the test resumed successfully completing phase 4, and 5. Deterioration was monitored throughout the extended testing but didn't impact the structural performance and the support achieved the target 45,000 cycles.

From the results of the test ,a comprehensive plan was devised. advising on when to carry out proactive replacement of the lower links, as well as any other work required to take the supports to the required 45,000 cycles.
