IMPACT OF CORROSION ON MINING EQUIPMENT

J. V. Pellegrino Jr.
Sr. Materials Consultant
RJ Lee Group

34 x 110 mm Chain Splice Link Failures

Analysis of Cracks in AFC Pans - Background

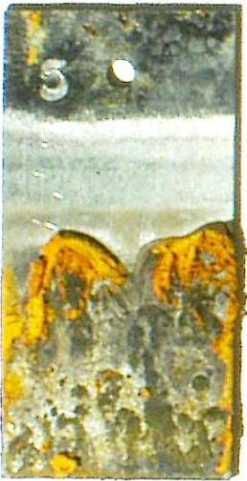
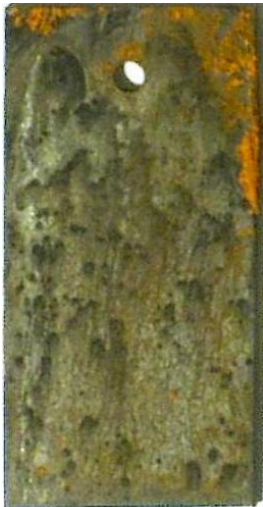
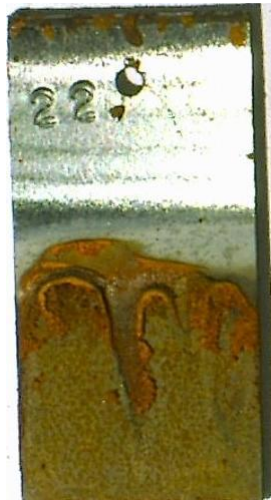
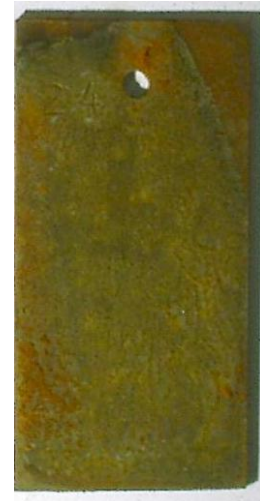
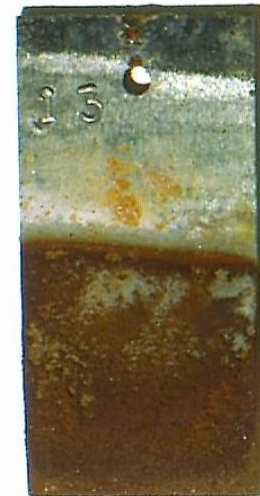
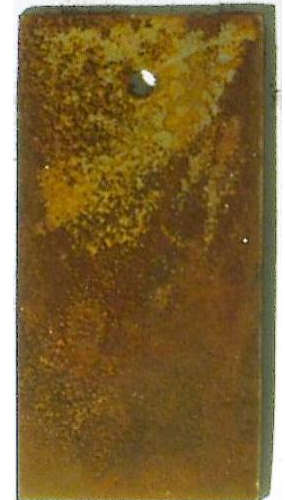
CROW

C10%RMW

CRMW

SROW

S10%RMW

SRMW

- Corrosion deposits heaviest on samples exposed to stagnant and circulating RO water.
- Visual examination after cleaning did not reveal the presence of excessive pitting. The uncorroded regions appeared to consist of mesas separated by relatively flat valleys.
- Samples exposed to circulating RO water and 10% raw mine water exhibited the severest corrosion.
- Difference in corrosion (weight loss) between partially submerged and fully submerged coupons was minimal.
- Under static conditions, there was no significant difference in degree of corrosion between RO treated water, raw mine water and 10% raw mine water.
- The corrosiveness of the RO treated water is primarily due to its lack of minerals and that in many cases it also contains more chlorides.

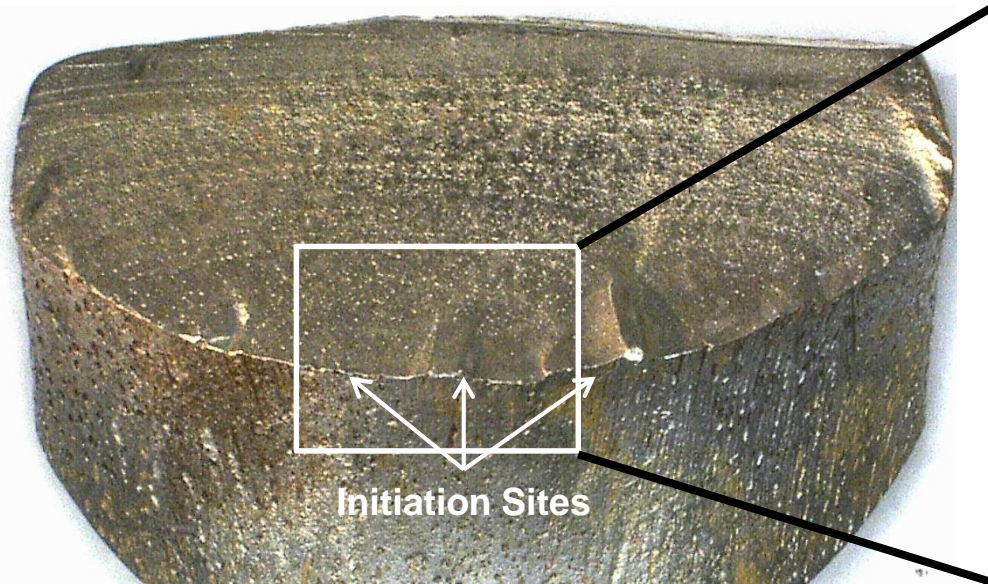
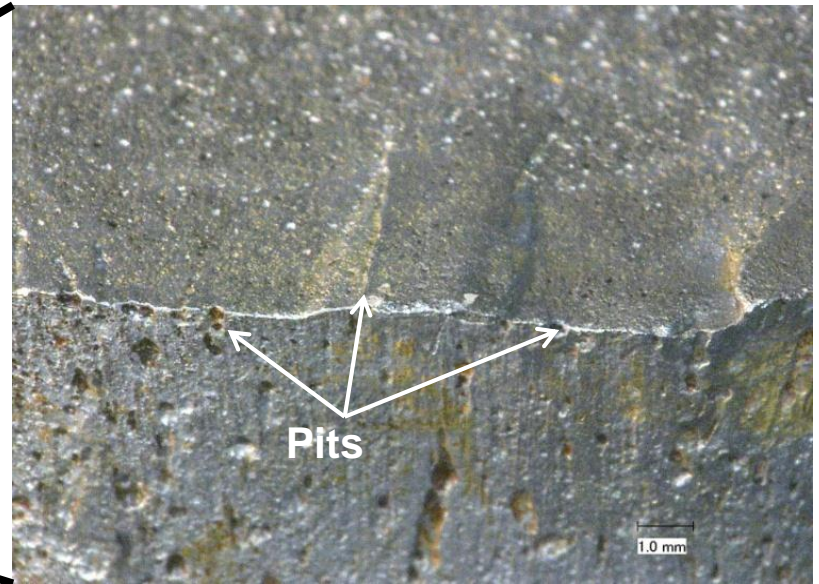
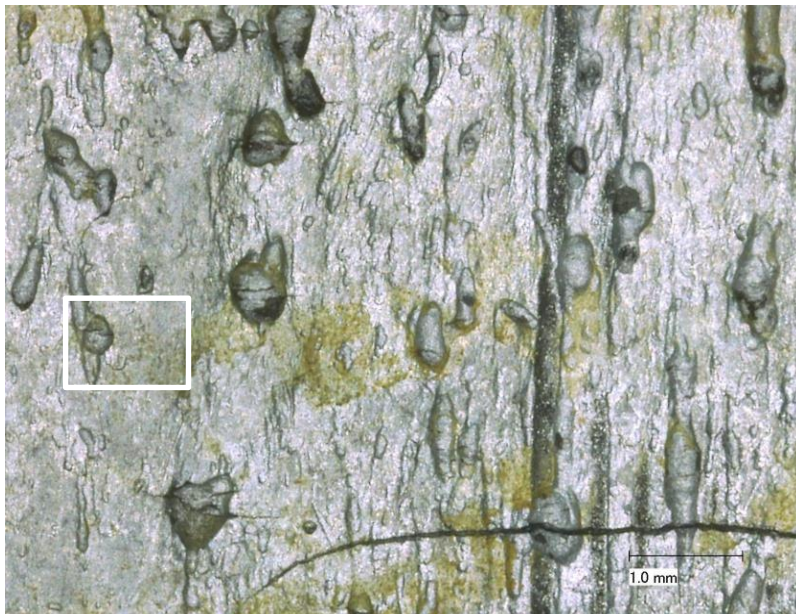
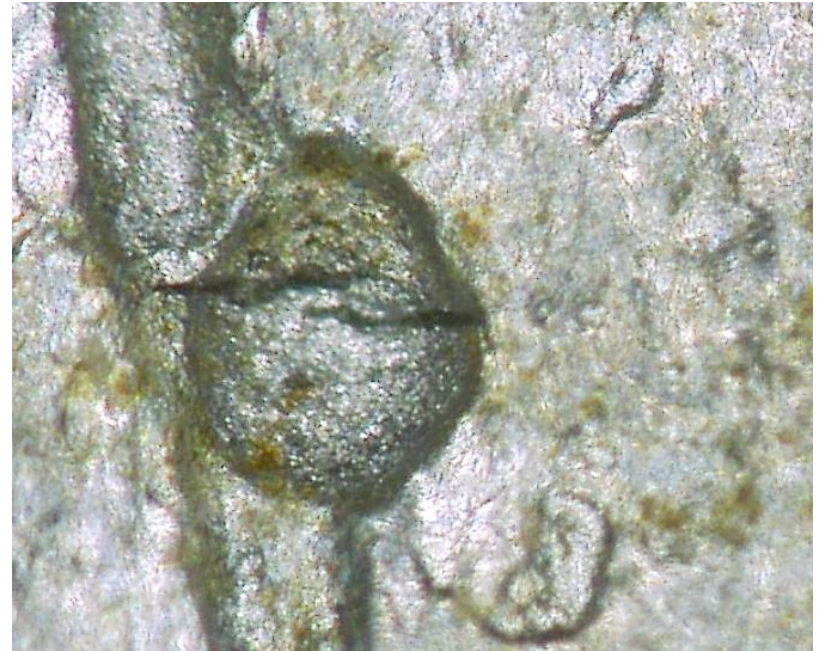
34 x 110 mm Chain Splice Link Failures

- Link was in service for 3 – 4 weeks.
- Used with non-galvanized standard DIN chain that had a “Tectyl” coating that exhibited satisfactory service performance.
- Alloy steel quenched and tempered to a hardness of 395 HWB (43.5 HRC)/~1337 MPa (194 ksi) and expected to exhibit a breaking load of 2000 kN (450 kips).
- Electroplated with ZnNi.

- Failure was environmentally governed and related to material selection, the environment, and operating conditions.
- Specifically, failure was caused by corrosion fatigue cracks that exhibited multiple initiation sites at corrosion pits on inside surface of links. The cracks propagated completely through the cross section before failure occurred.
- Chemical composition and hardness/strength satisfied the requirements of the governing specifications.
- The ability of the splice link to tolerate a full thickness crack before terminal fracture shows the nominal stresses were low and the material exhibited sufficient toughness for the application.
- Under the same mining conditions, un-galvanized splice links of the same composition and strength level have exhibited satisfactory service performance.

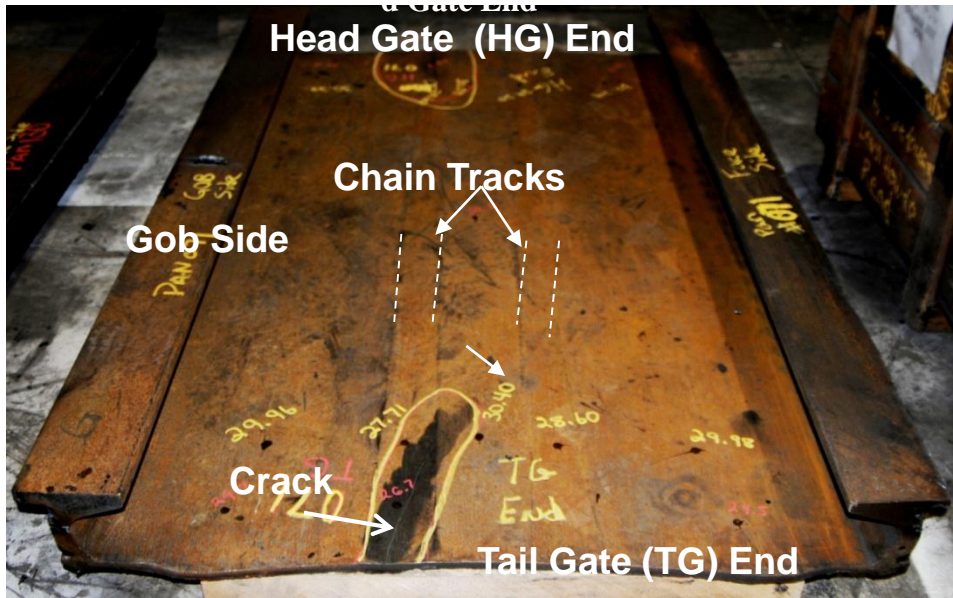
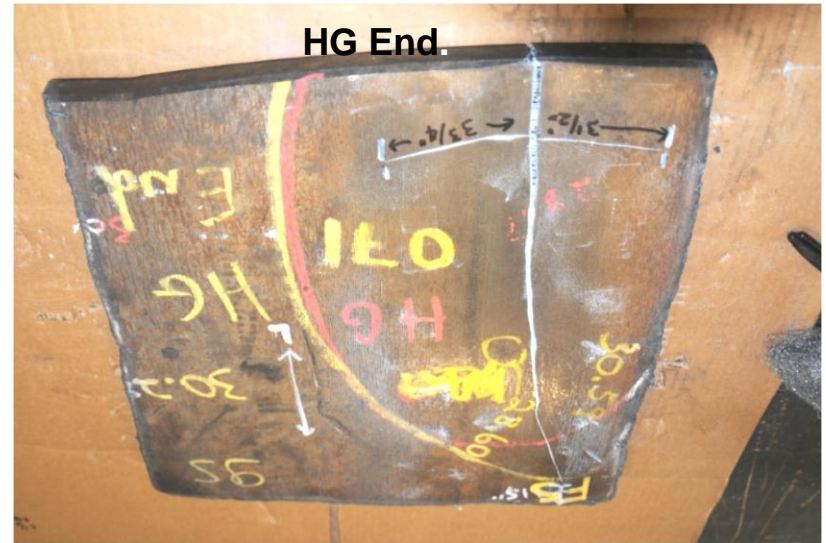
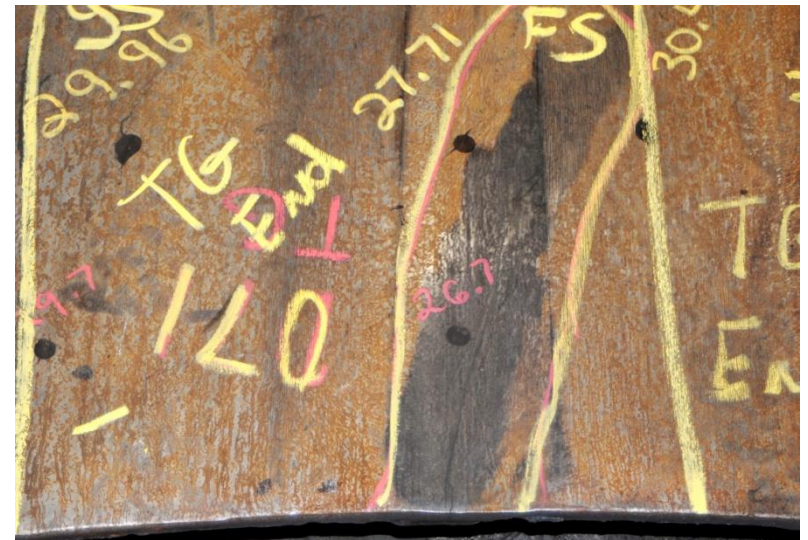
Pan 71 deck plate

- **Visual examination of pans in a rebuild shop revealed the presence of numerous longitudinal cracks in the top deck plate, most of which were within or immediately adjacent to the chain tracks.**

- **Of the 18 pans included in the investigation, most contained multiple longitudinal cracks.**
- **Crack lengths ranged from 50.8 mm to 1778 mm and were present on both head gate (HG) end, tail gate (TG) end or both ends and gob-side, face side or both sides.**

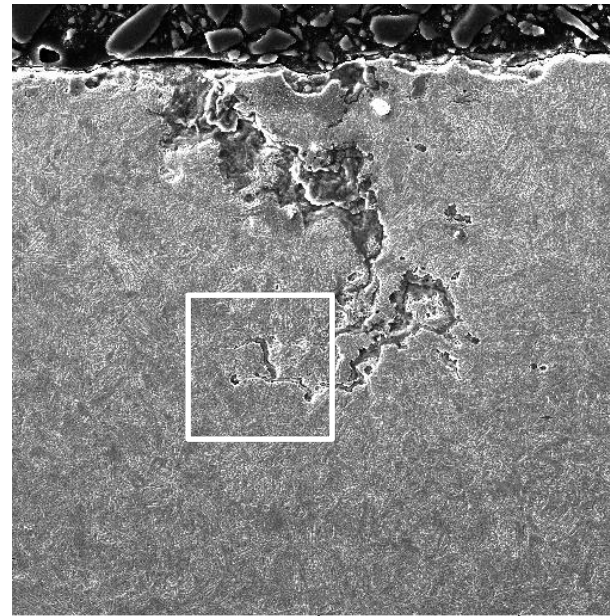
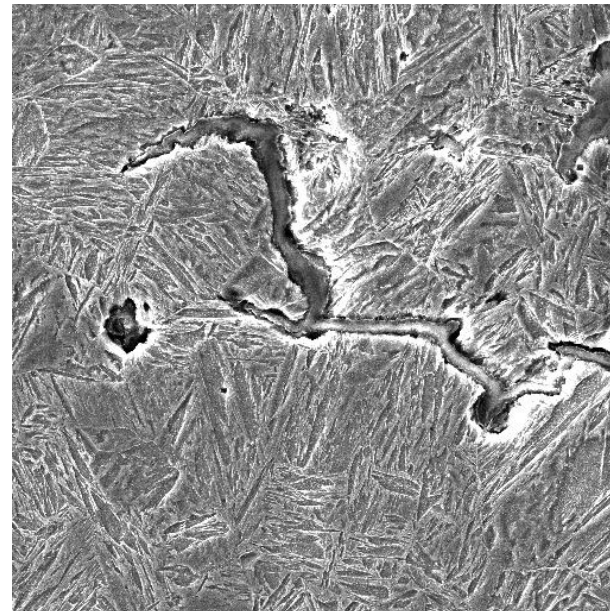
0.16 mm deep IG crack on chain contact surface of Pan 71 deck plate.

- **Irrespective of plate grade, source, orientation, and mechanical properties, cracks initiated in the chain contact surface of both the 450 HB and 500 HB abrasion resistant plates.**
- **In all cases, fractographic/metallographic examination produced the following conclusions**
 - **The cracking that developed in service was progressive, exhibiting multiple crack arrest markings and intergranular fracture.**
 - **Fracture surfaces of all tensile and CVN impact tests exhibited predominantly ductile fracture.**
 - **As-expected, the cryogenic laboratory fractures exhibited brittle cleavage fracture.**
 - **All deck plates exhibited a uniform martensitic microstructure.**

- **Cracking is consistent with both stress corrosion and corrosion fatigue.**
 - **Corrosion fatigue is the combined action of fatigue and corrosion and can produce a failure in fewer cycles and lower loads than if corrosion or fatigue were acting alone.**
