A Case Study of a Low Overburden Longwall Recovery With Pre-Developed Recovery Entries

Signal Peak Energy, LLC.

Abstract

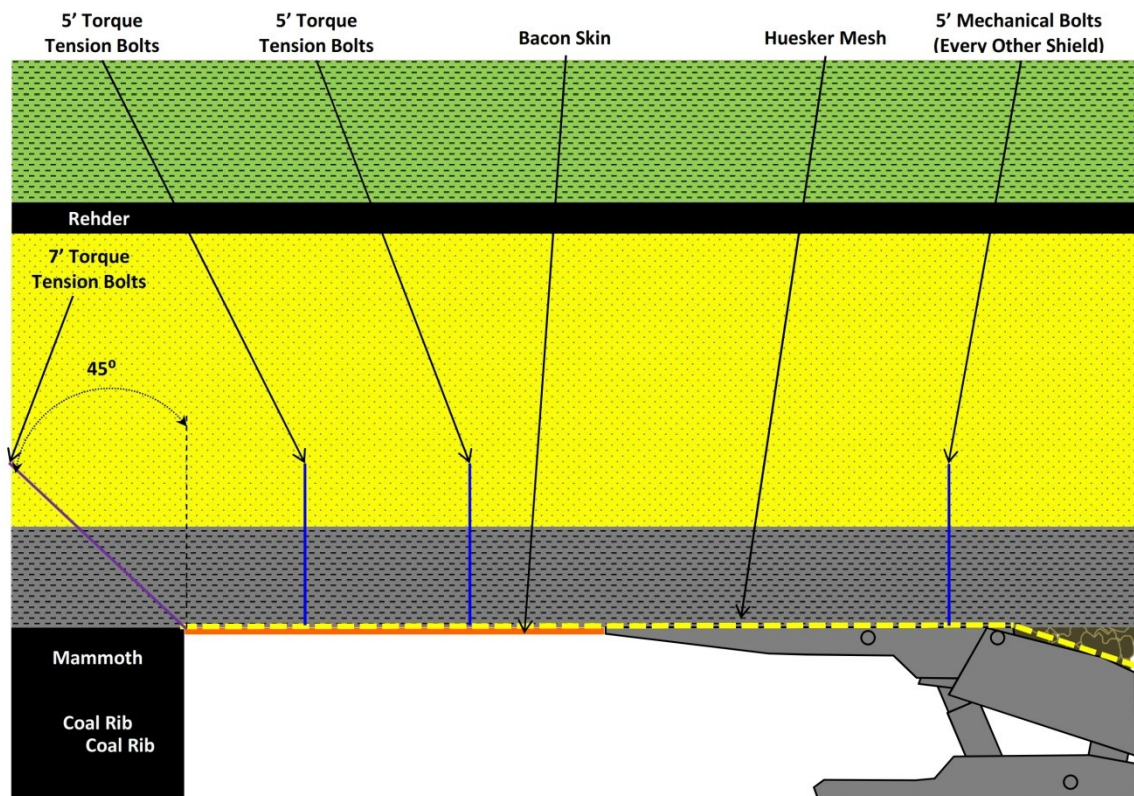
1Right Conventional Move Roof/Supplemental Support

- Completed mining the 1 Right panel in March 2011.
- 1 Right Conventional Conditions
 - Shallow cover (200' Overburden).
 - Normal lithology (Sandstone Top).
 - Normal mining height (10').
 - Interburden between the Mammoth and Rehder Seams greater than 20'.
- Huesker Meshing was planned at 10 passes with a finished tip to face distance of 10 feet.
- As we started the meshing process we experienced some cap rock issues which slowed the bolt installation.
- As the meshing process continued we experienced serious convergence on the shields (old style yield valves). The yield valves were yielding well below their limit causing shield leg loss at a rapid rate; making it tougher to mesh and bolt.
- During this time frame every step of the conventional move became a challenge.
- Along with continued convergence on the shields we had several shield tips down.

- During extraction of the AFC, headgate and tailgate we started to develop a cutter on the solid rib line.
- It was decided at this time to bring in the Fletcher roof bolter and spend the time to bolt the face with a denser and more substantial support .

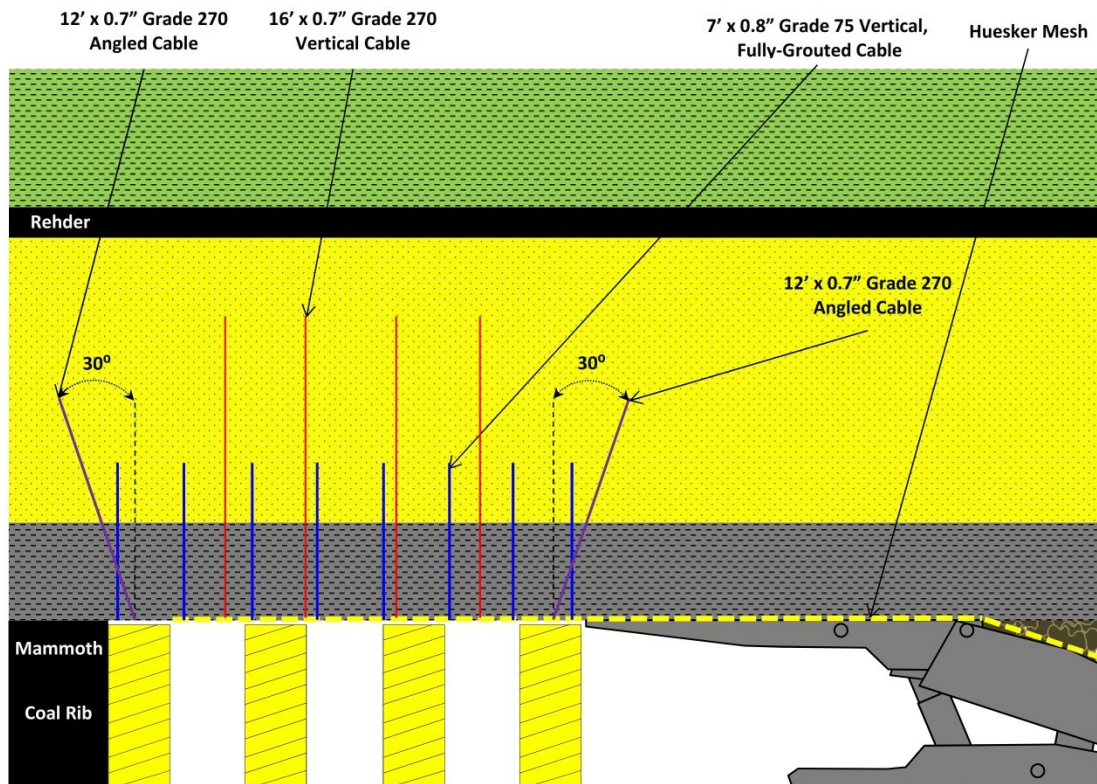
2 Right Recovery Room Roof/Supplemental Support

- When the fender pillar was approximately 15 feet at the tailgate and 18 feet at the headgate a weight transfer occurred. Both the shields and the standing support were immediately converged approximately 24 inches. After the weight transfer event many of the shields were ironbound.

- Shield toes were blasted and recovery work continued. The sudden convergence damaged the yield valves. The yield valves were replaced with rock burst valves .

- Damage was found at the chutes at the rib line in two of the chutes, #4 being the worst. Several of the pumpable crib in the recovery room had failed.

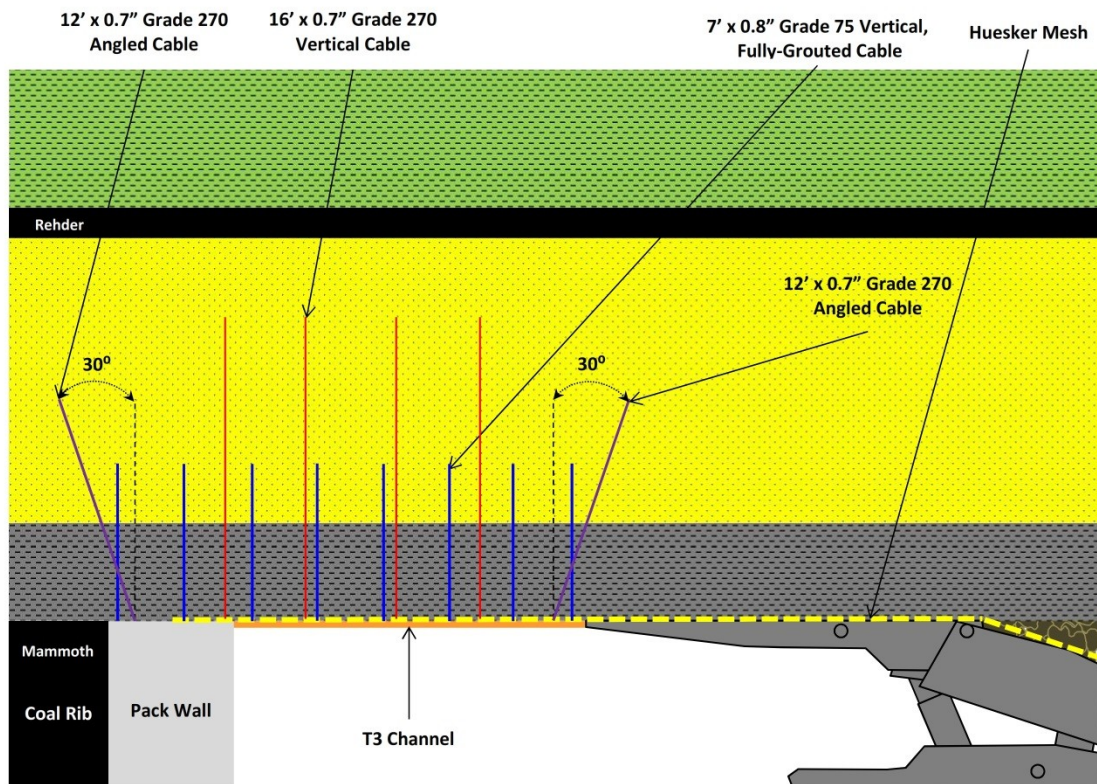
2 Right Recovery Room Roof/Supplemental Support

- Tech-seal was pumped into this void to create a pack wall matching a 900 psi coal strength. With the pack wall completed and a minimal cure time all convergence slowed.
- Shields were extracted at a slow pace due to the majority being iron bound and the Huesker mesh not being in the desired or proper position.
- The longwall extraction took 60 days (hanging mesh to final shield pulled).

- Prior to the weighting transfer the normal mining rate was reduced due to the meshing installation.
- When the fender pillar yielded the shields converged, and the standing support failed.
- The standing support density of 0.34 was underestimated.

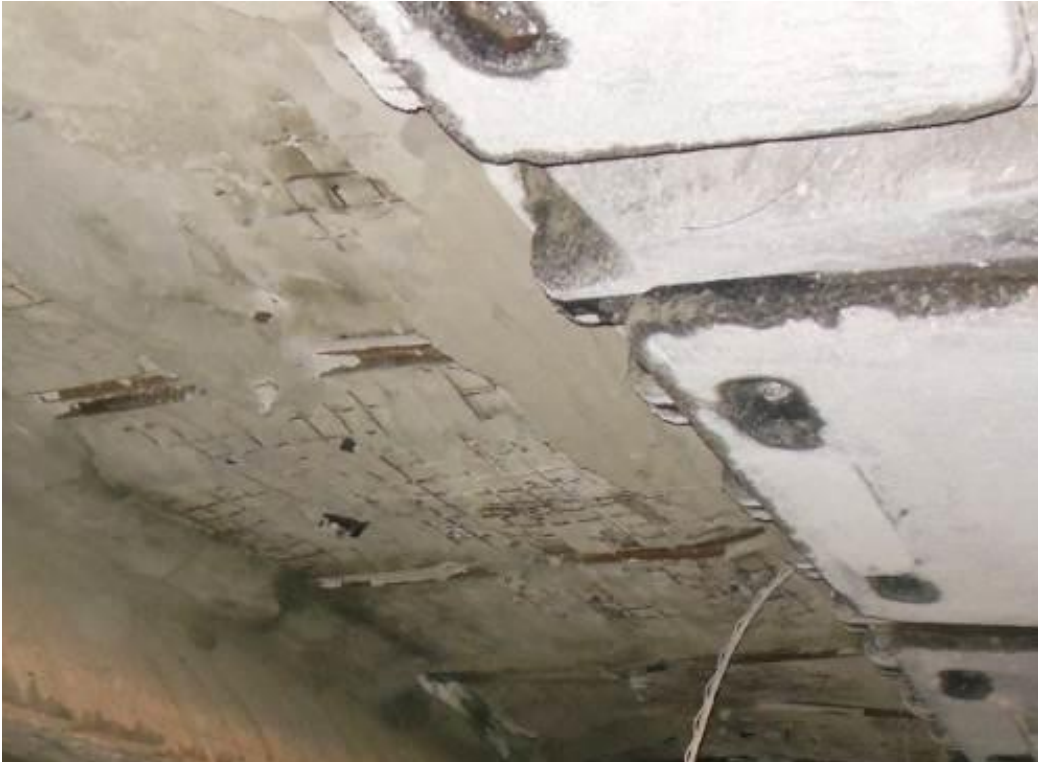
Exposed bolts, channel, and steel mesh

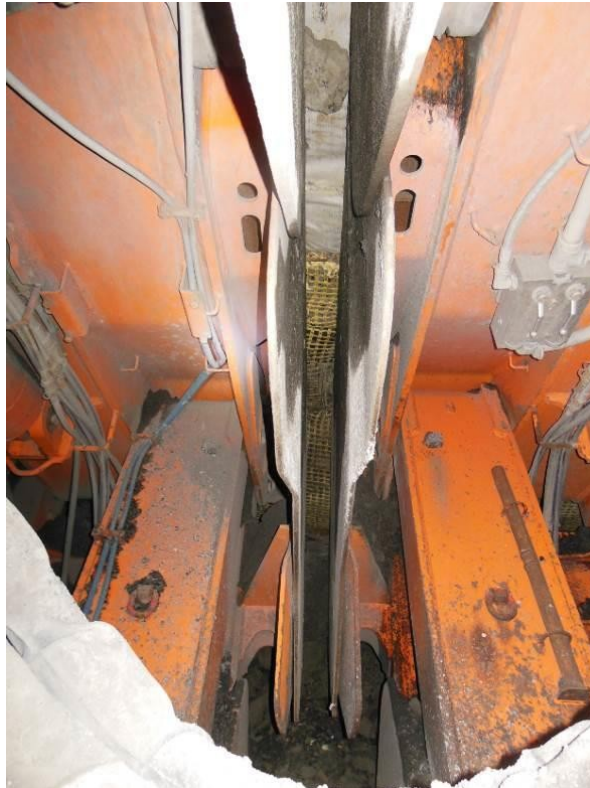
Huesker mesh (yellow) laid down behind the shields

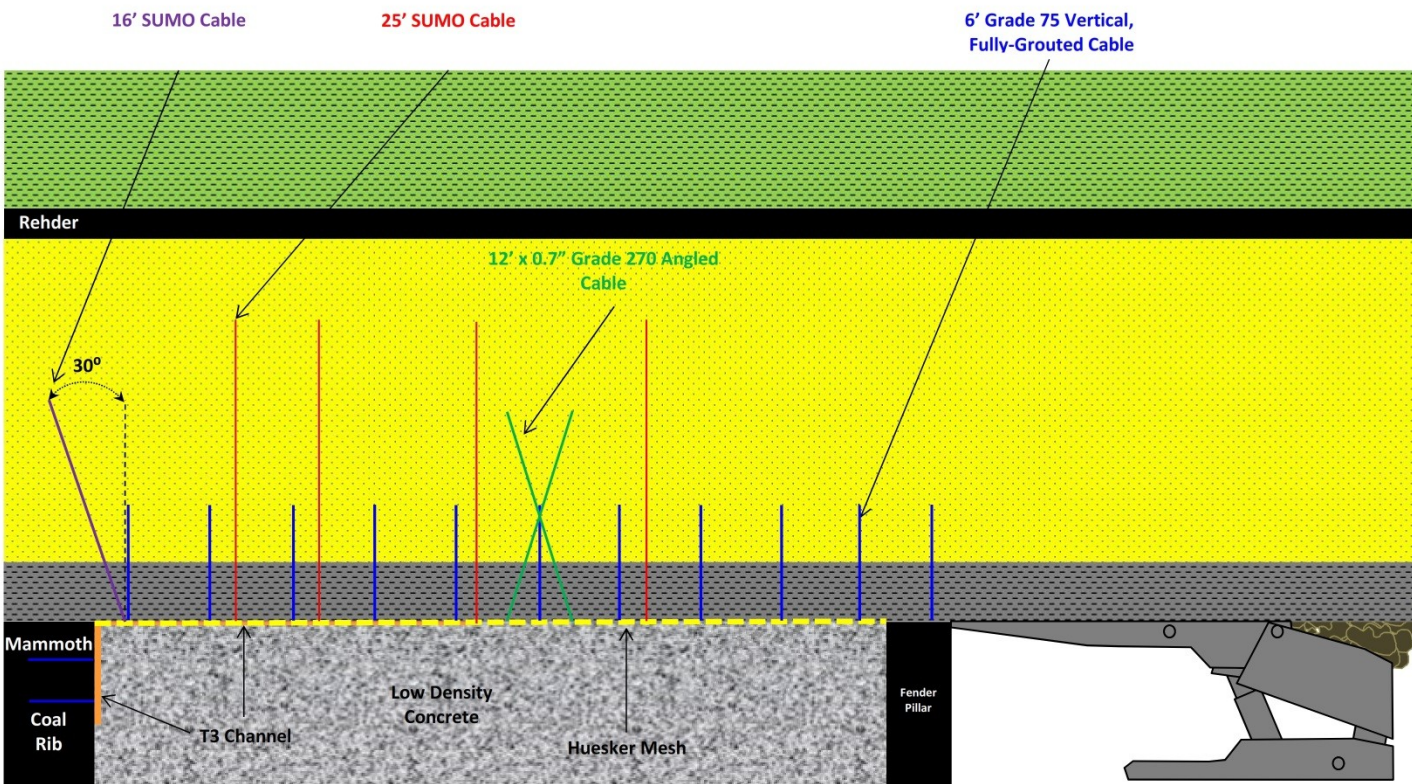
4 Right Recovery Room Roof/Supplemental Support

- Completed mining the 4 Right panel in March 2015.
- 4 Right Recovery Room Conditions
 - Shallow cover (200' Overburden).
 - Normal lithology (Sandstone Top).
 - Normal mining height of 11' (9' of coal & 2' floor rock).
 - Interburden between the Mammoth and Rehder Seams greater than 20'.
- Designed without the need to stop and install any supplemental roof support.
- Pillar corners remained sharp.
- Abutment load transferred as planned.
- Shields yielded and leg pressures returned back to normal when the roof caved behind the shields
- After the shields were in final position convergence occurred between chute 1 and chute 2.

- TG inby the face remained stable.
- Cracks and pillar corner sloughage observed in chutes 1, 2 and 3.
 - Loading occurred after the shields had set for five days. Inconsistency with a portion of the backfill.

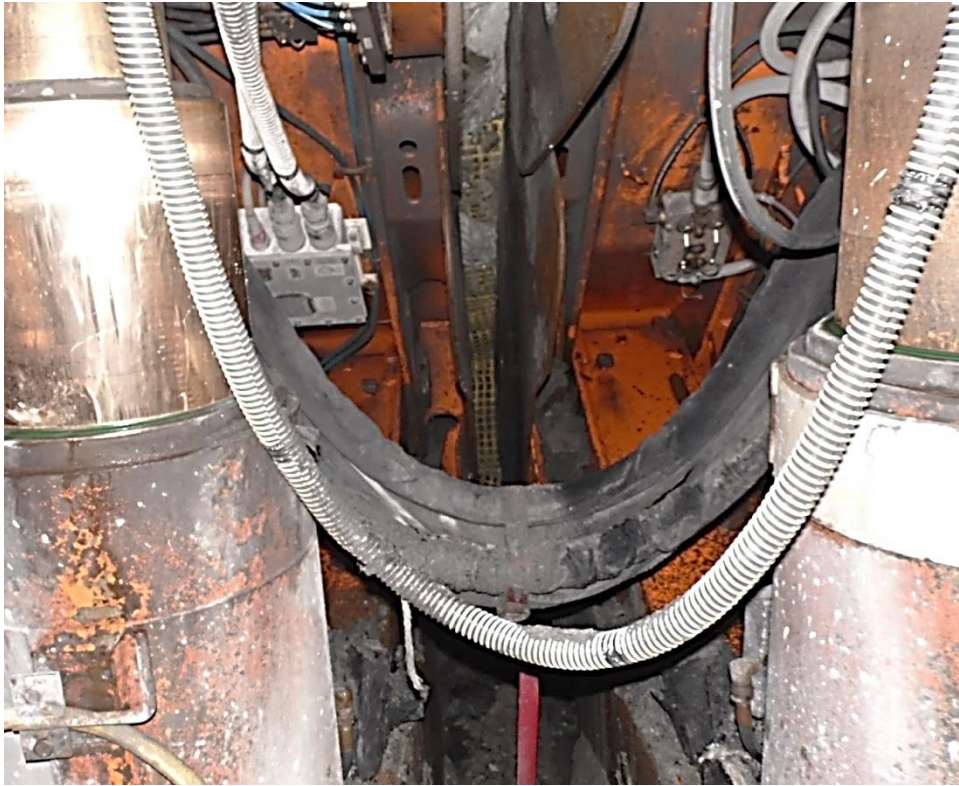
Huesker mesh (yellow) laid down behind the shields.

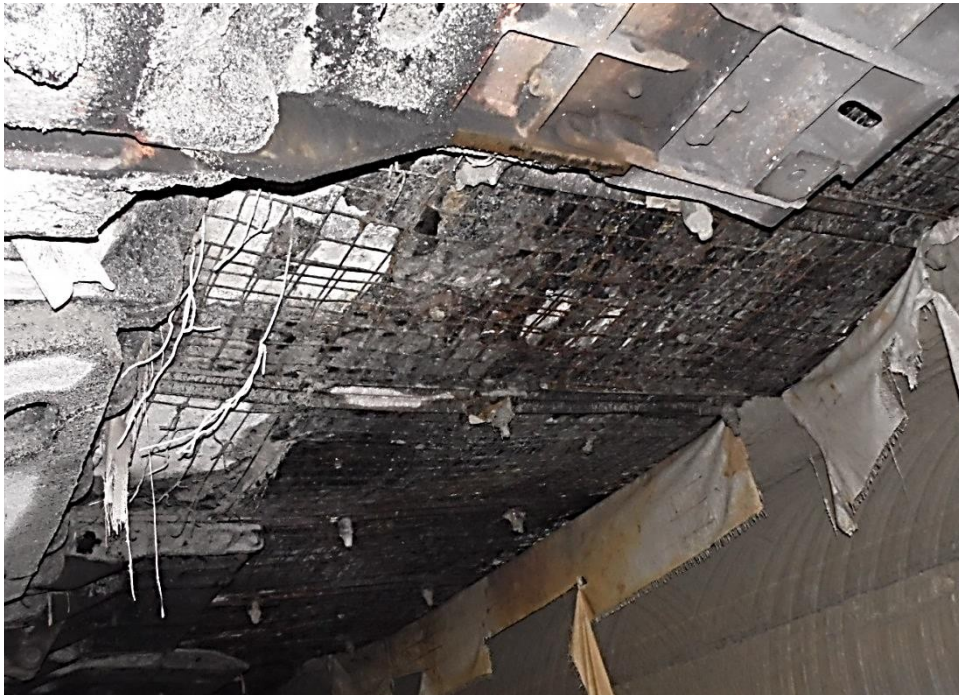
Exposed bolts, channel, and steel mesh.

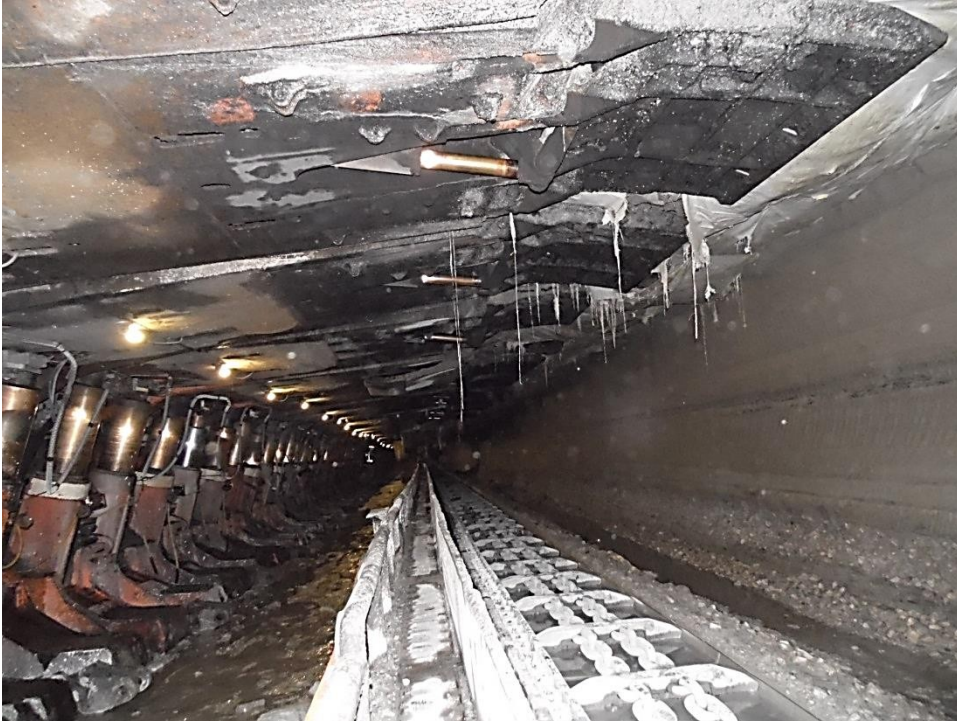
Shield in final position.

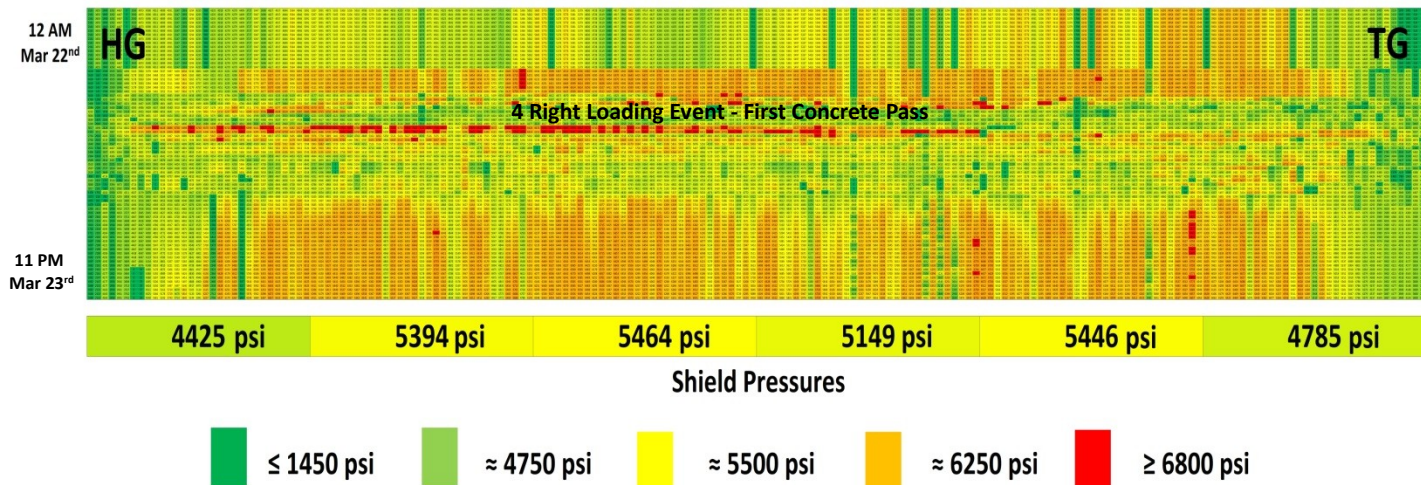
Signal Peak Energy - 4 Right Shield Leg Pressures Mining into Recovery Room

- LW extraction took only 14 days
- Shield leg pressures showed loading when the first cut was made into the backfill.
- Chute pressure sensor data shows nearly all the pressure increases occurred during the first shearer pass into the backfill. The highest pressure observed was 130 psi in chute 4 ten feet from the coal fender.

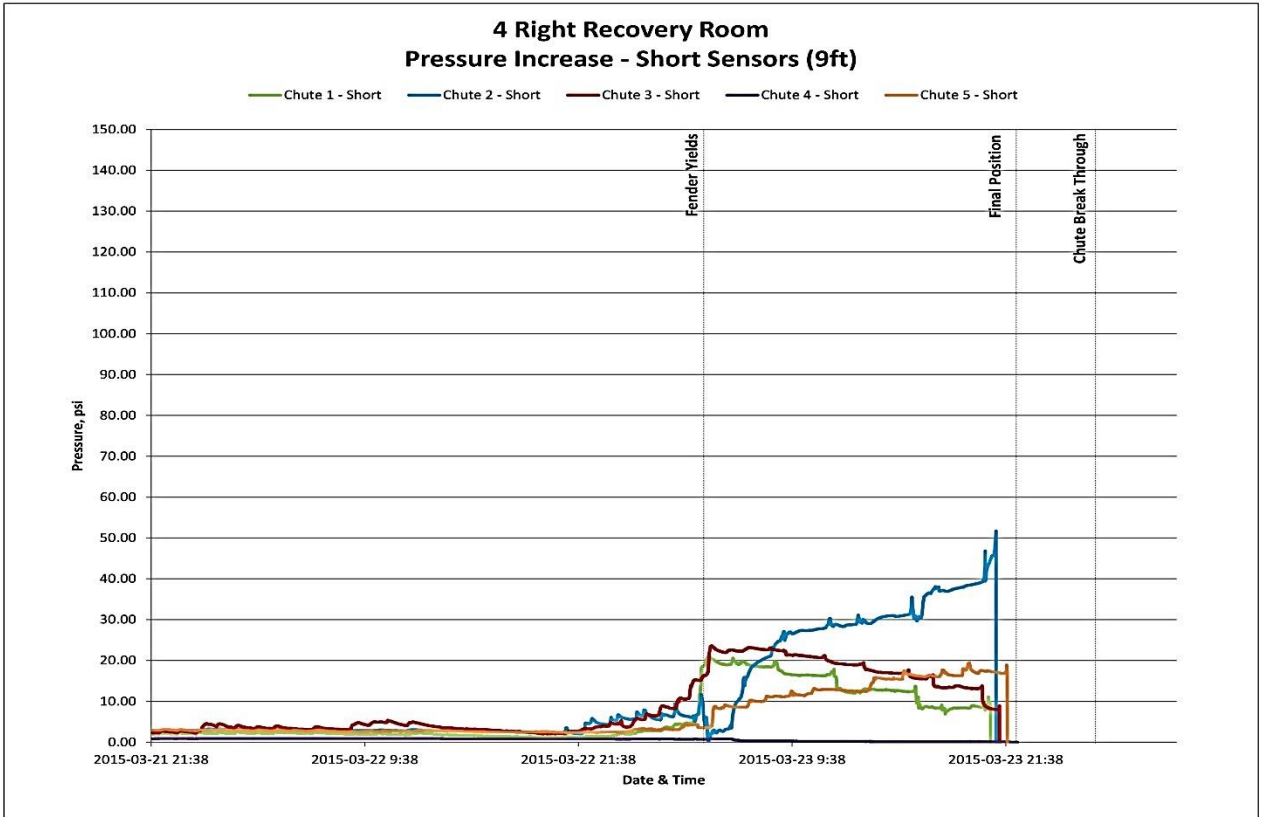
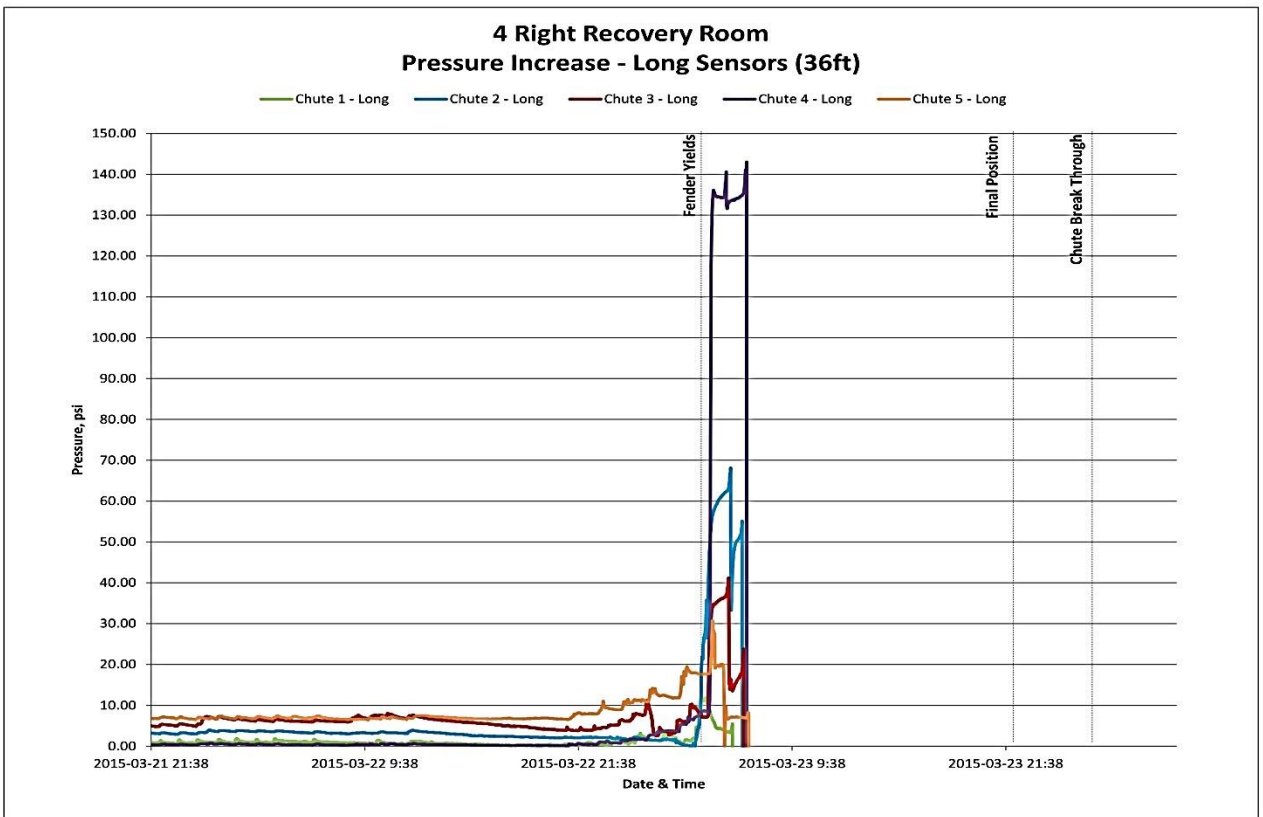
4 Right Backfill Borehole Pressures

When the shields are at final position backfill thickness is 10'. At Chute breakthrough the backfill thickness is 1'-2'.
